**The 7th International Forum on the Decommissioning of the Fukushima Daiichi
Nuclear Power Station @Iwaki Performing Arts Center Alios**

Historical challenges to understand the in-reactor and containment status of Units 1 to 3

August 28, 2023

TEPCO

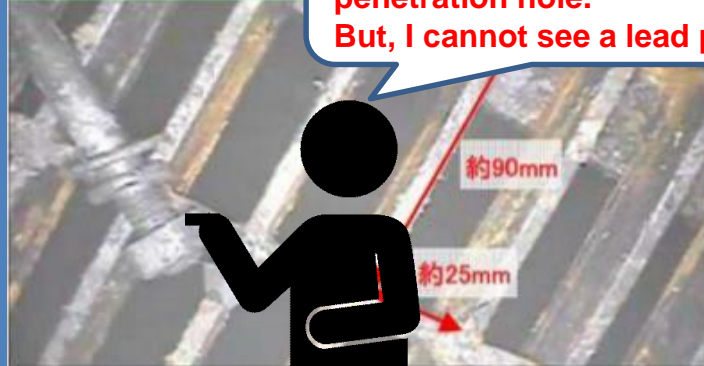
⑤ グレーチング上

This bolt must have fixed a lead plate inside the X100 penetration hole. But, I cannot see a lead plate!

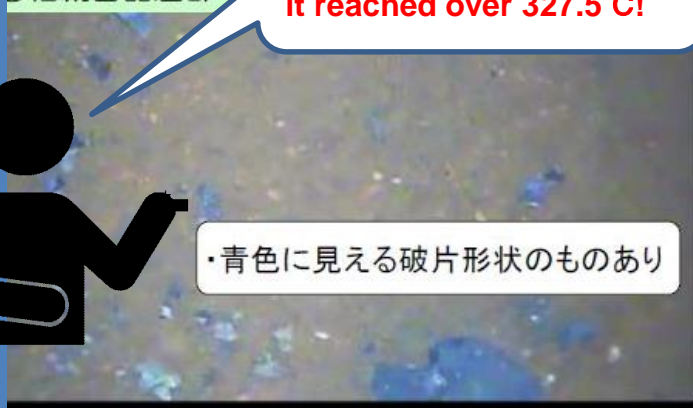
③ 格納容器底部

This is a remaining of melted lead. That means it reached over 327.5°C!

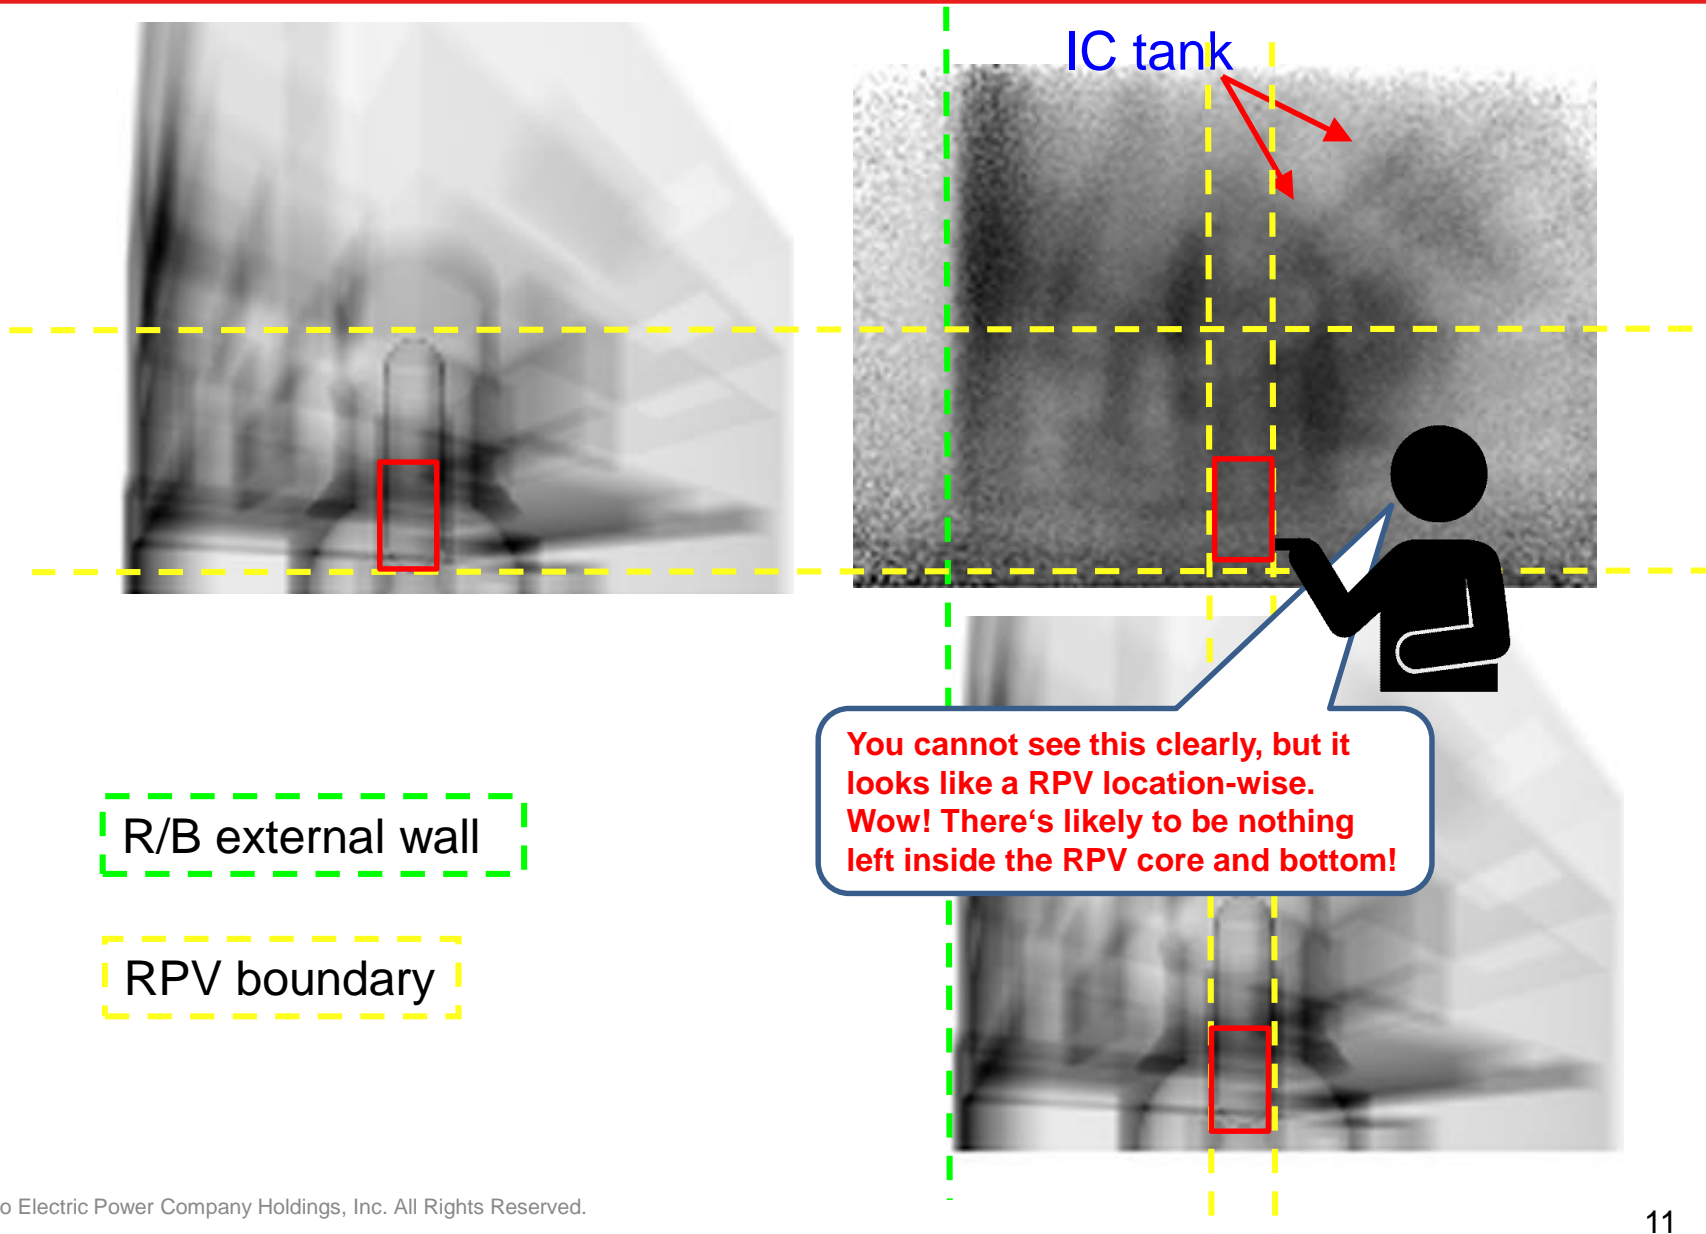
You cannot see this clearly, but it looks like a RPV location-wise. Wow! There's likely to be nothing left inside the RPV core and bottom!

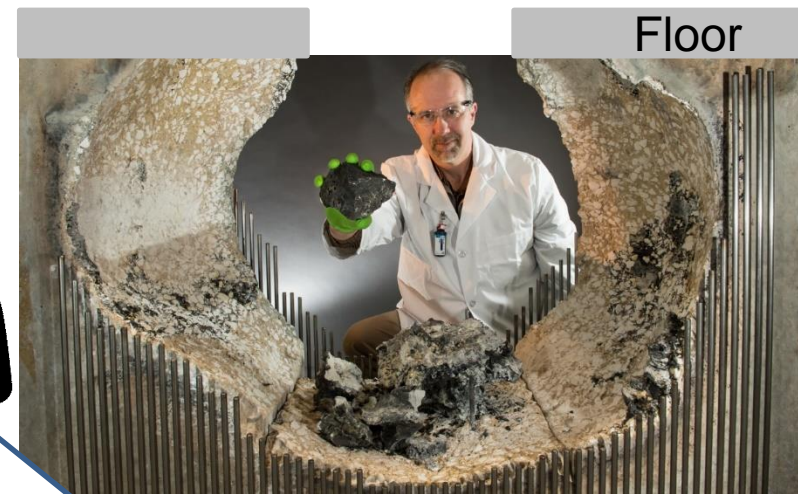
A. Near the pedestal opening

The MCCI knowledge obtained through the past experiments suggested if melted fuel drops to the concrete, it eats away the concrete vertically and then horizontally. The situation of the pedestal at Unit 1 is quite different from that!

It was confirmed that the lower part of concrete was lost and rebar were exposed at the opening of the pedestal.

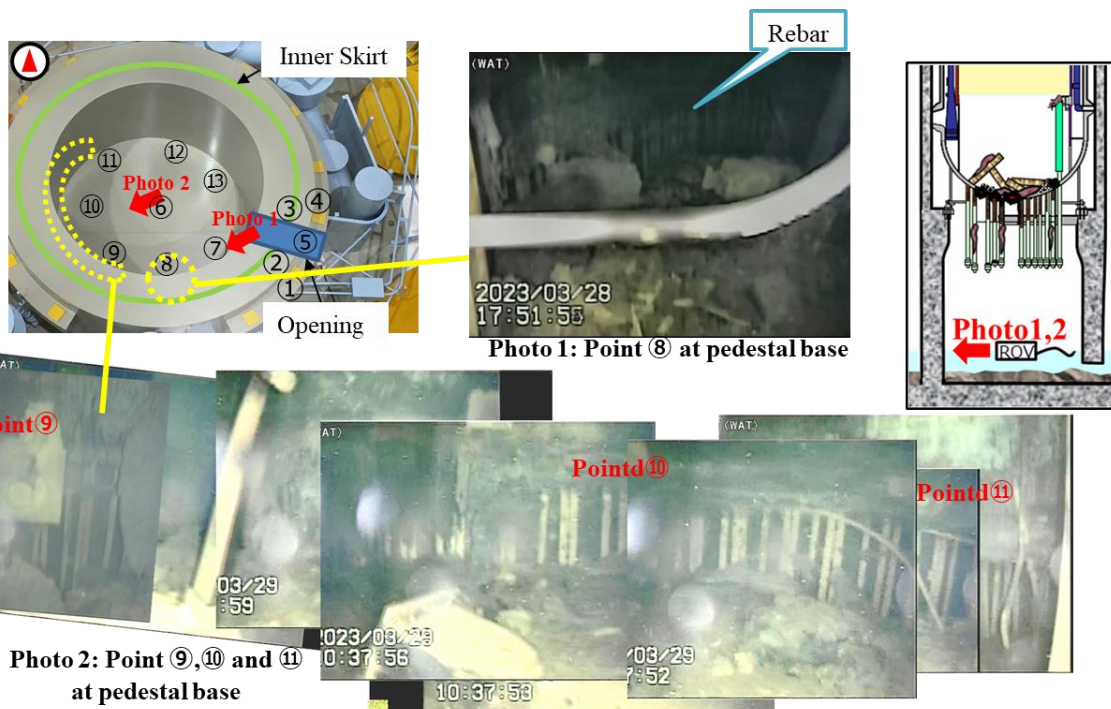
- The ROV couldn't reach points ⑧, ⑨, and ⑩. But the footage taken at point ⑤ and the one taken during its movement enabled us to ascertain the base parts of pedestal. <Photo1,2>
- The observed base parts look similar to other investigation points with concrete at the lower inner part of the pedestal partially lost and rebars exposed. <Photo1,2>

The concrete has been confirmed to be lost along all circumference inside the pedestal.

- Three steps are being taken, considering that the concrete has been lost at the lower part of the pedestal.
 1. Assessment of the effects have been conducted by evaluating the strength of the inner skirt remaining in the pedestal. The result shows, even with the Mar. 2011 class earthquake, the structure will not suffer large scale collapse.

2. Assuming that the support function of the pedestal has deteriorated, a conservative scenario has been made. The result shows 0.03~0.04mSv per incident at the site boundary, which is much lower than 5mSv per incident, the criteria for accident scenarios.

3. In case of loss of the supporting function, measures to prevent the radioactive dust from dispersing will be in place.
 - Preparation to stop injecting nitrogen in case of emergency based on the idea that the amount of nitrogen injected should be smaller than that of exhaust for ease of controlling the dust leakage.

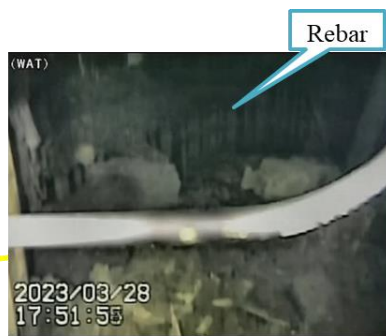
Photo 1: Point ⑧ at pedestal base

- The ROV couldn't reach points ⑧, ⑨, and ⑩. But the footage taken at point ⑤ and the one taken during its movement enabled us to ascertain the base parts of pedestal. <Photo1,2>
- The observed base parts look similar to other investigation points with concrete at the lower inner part of the pedestal partially lost and rebars exposed. <Photo1,2>

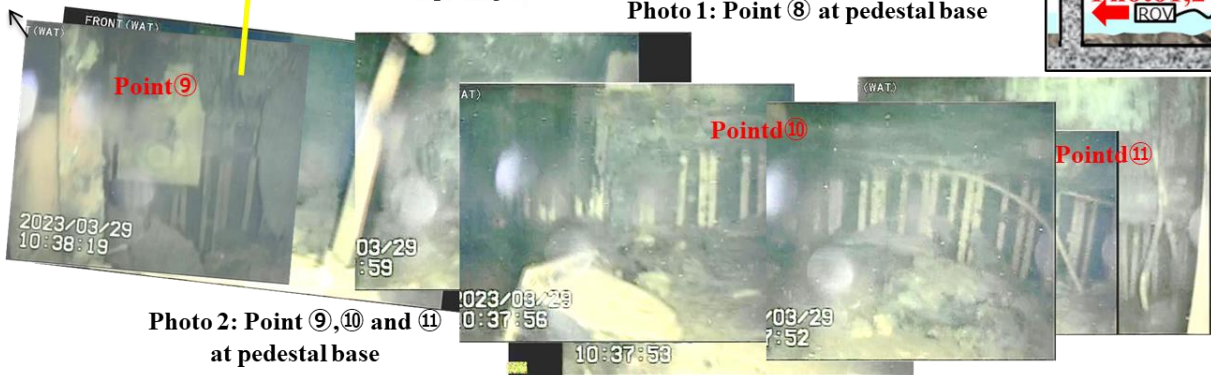
Photo 2: Point ⑨, ⑩ and ⑪ at pedestal base

**Why is it that pedestal concrete has been lost around almost its entire circumference?
Why are the missing sections all approximately the same height?**

The concrete has been confirmed to be lost along all circumference inside the pedestal.

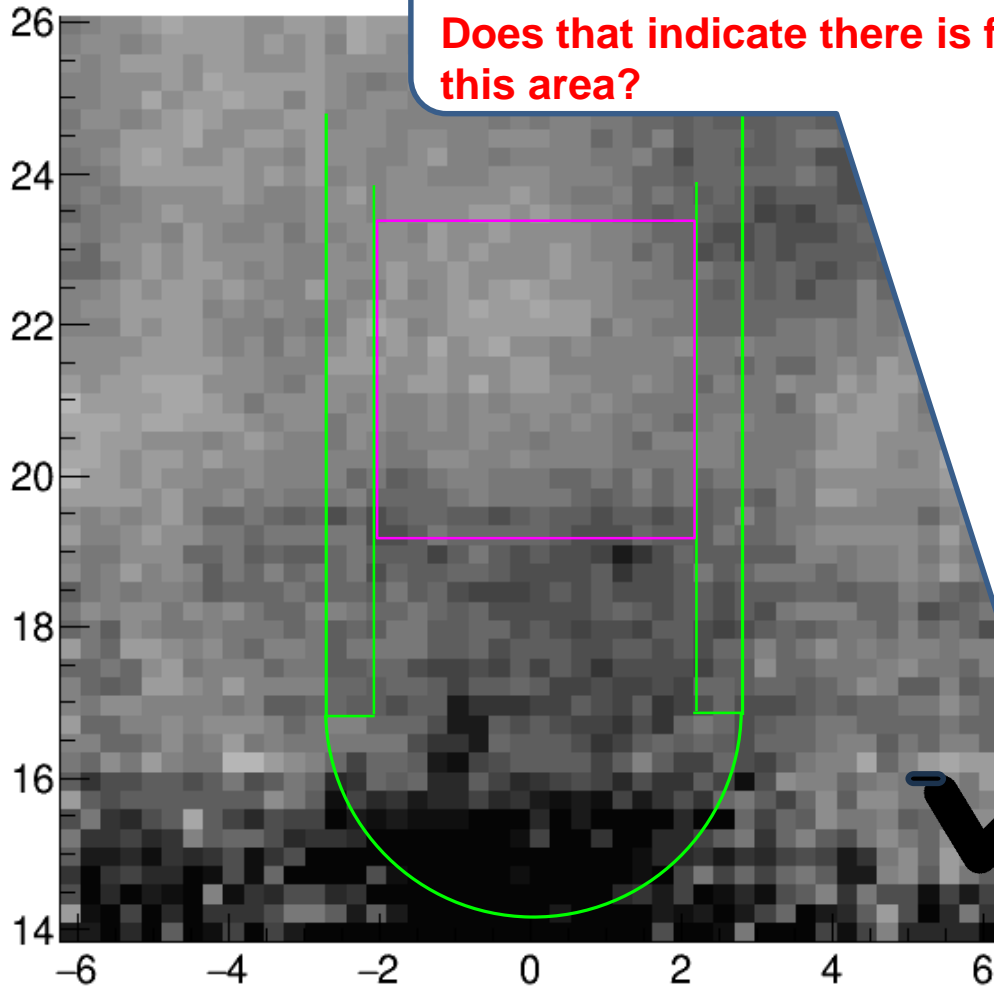
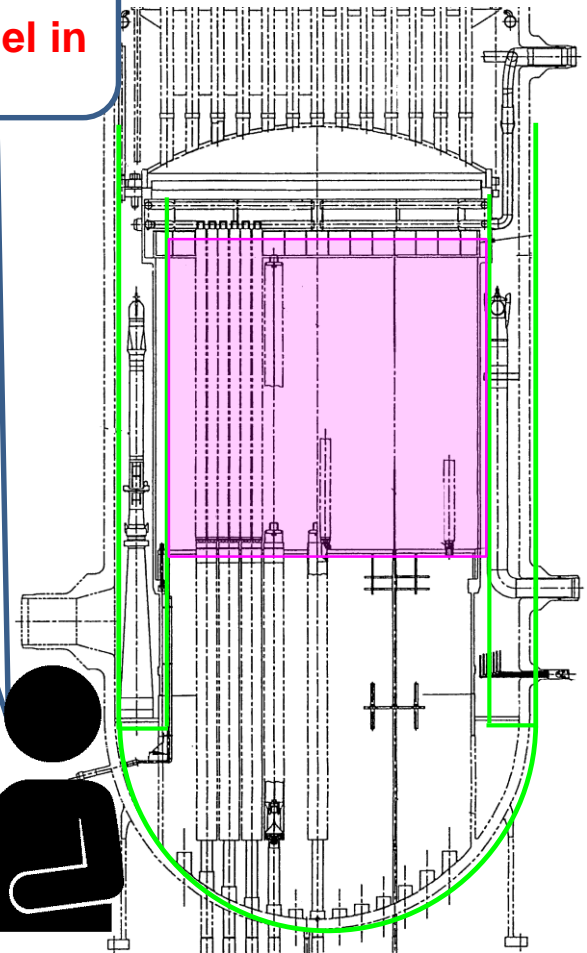
Cross section of lower part of RPV

There is a dark area at the bottom of RPV.
Does that indicate there is fuel in this area?

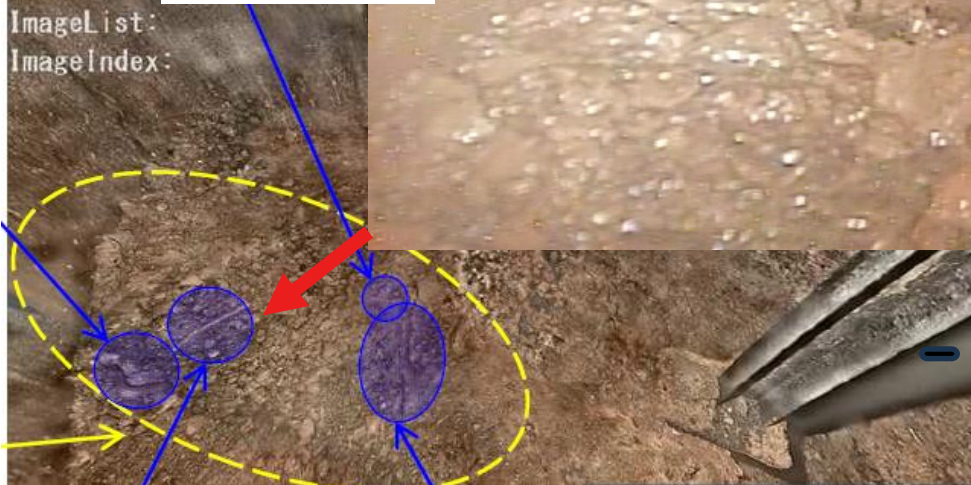
Pebble-like deposits spread all over the floor inside the pedestal. Moreover, there are a couple of places where deposits are accumulated higher than others

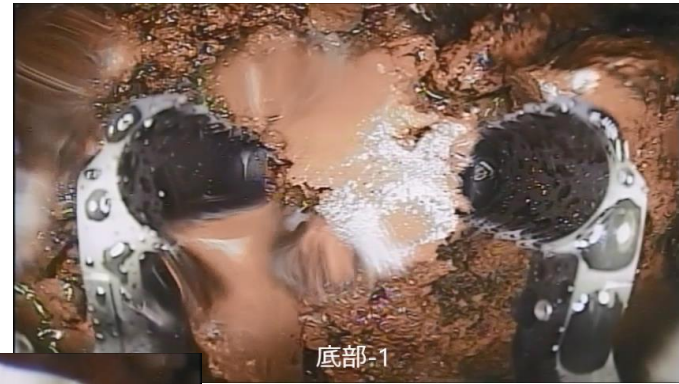
Pebble-like or plate-like deposits can be moved.

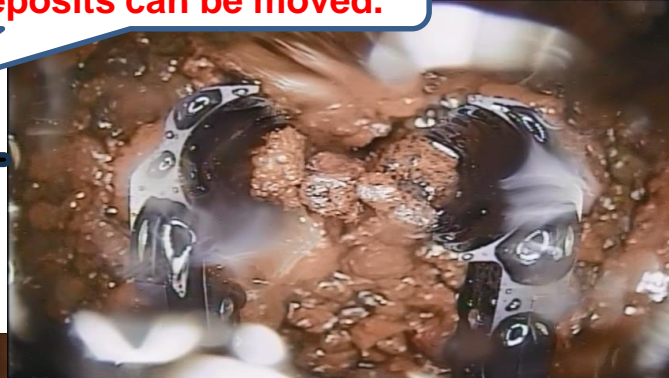
But, rock-like deposits can't be moved.

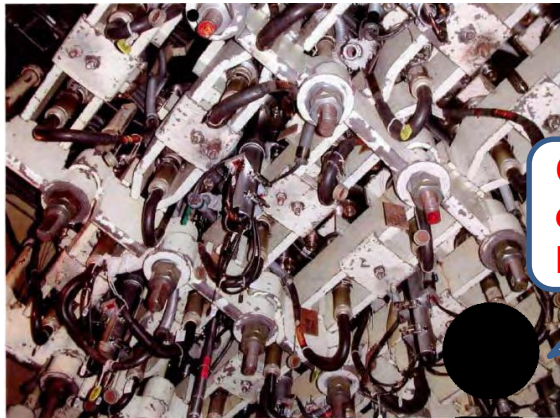
CRD housings are exposed with CRD housing support lost

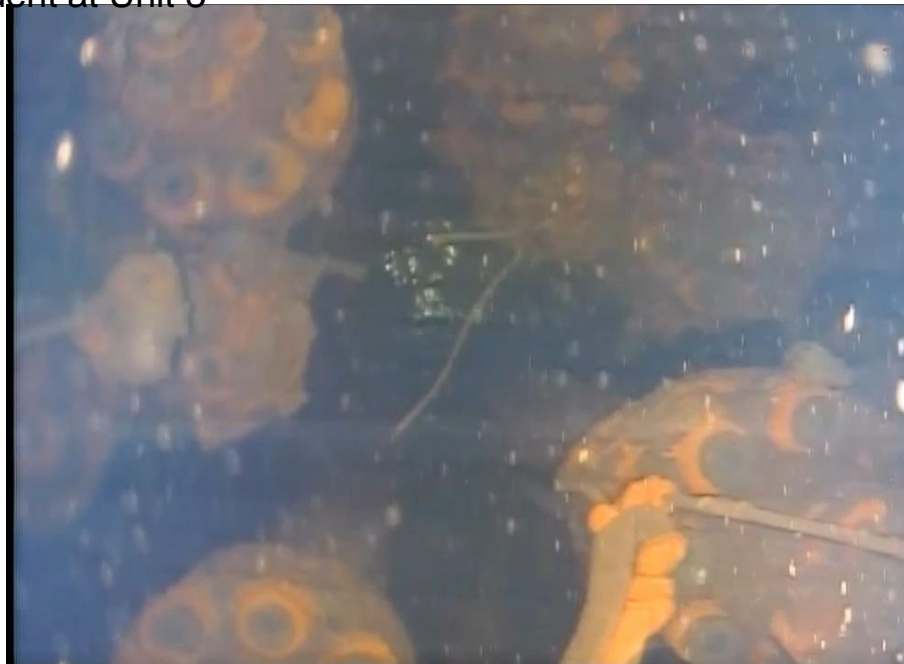
Wavering water surface indicates water coming down from the reactor

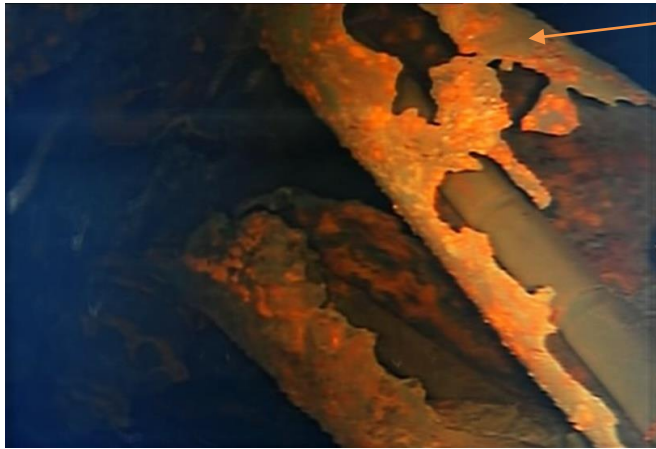
A cylinder-like structure (presumed CR guide tube)

It looks like an index tube which is responsible for inserting a control rod into a core. Structures that had been present in the reactor dropped to the bottom of PCV.

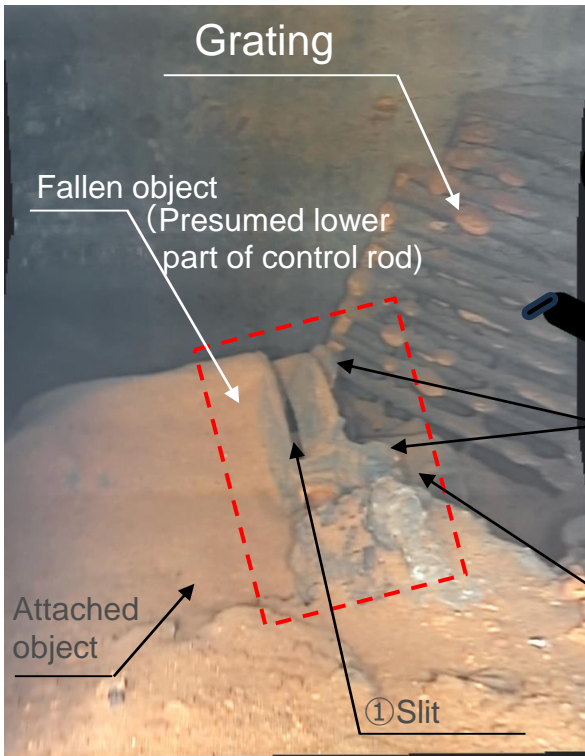
Referring to the figure of control rod, this really looks like a speed limiter that is at the lower part of the control rod. It dropped from the fuel loading position in the reactor to the bottom of the PCV.

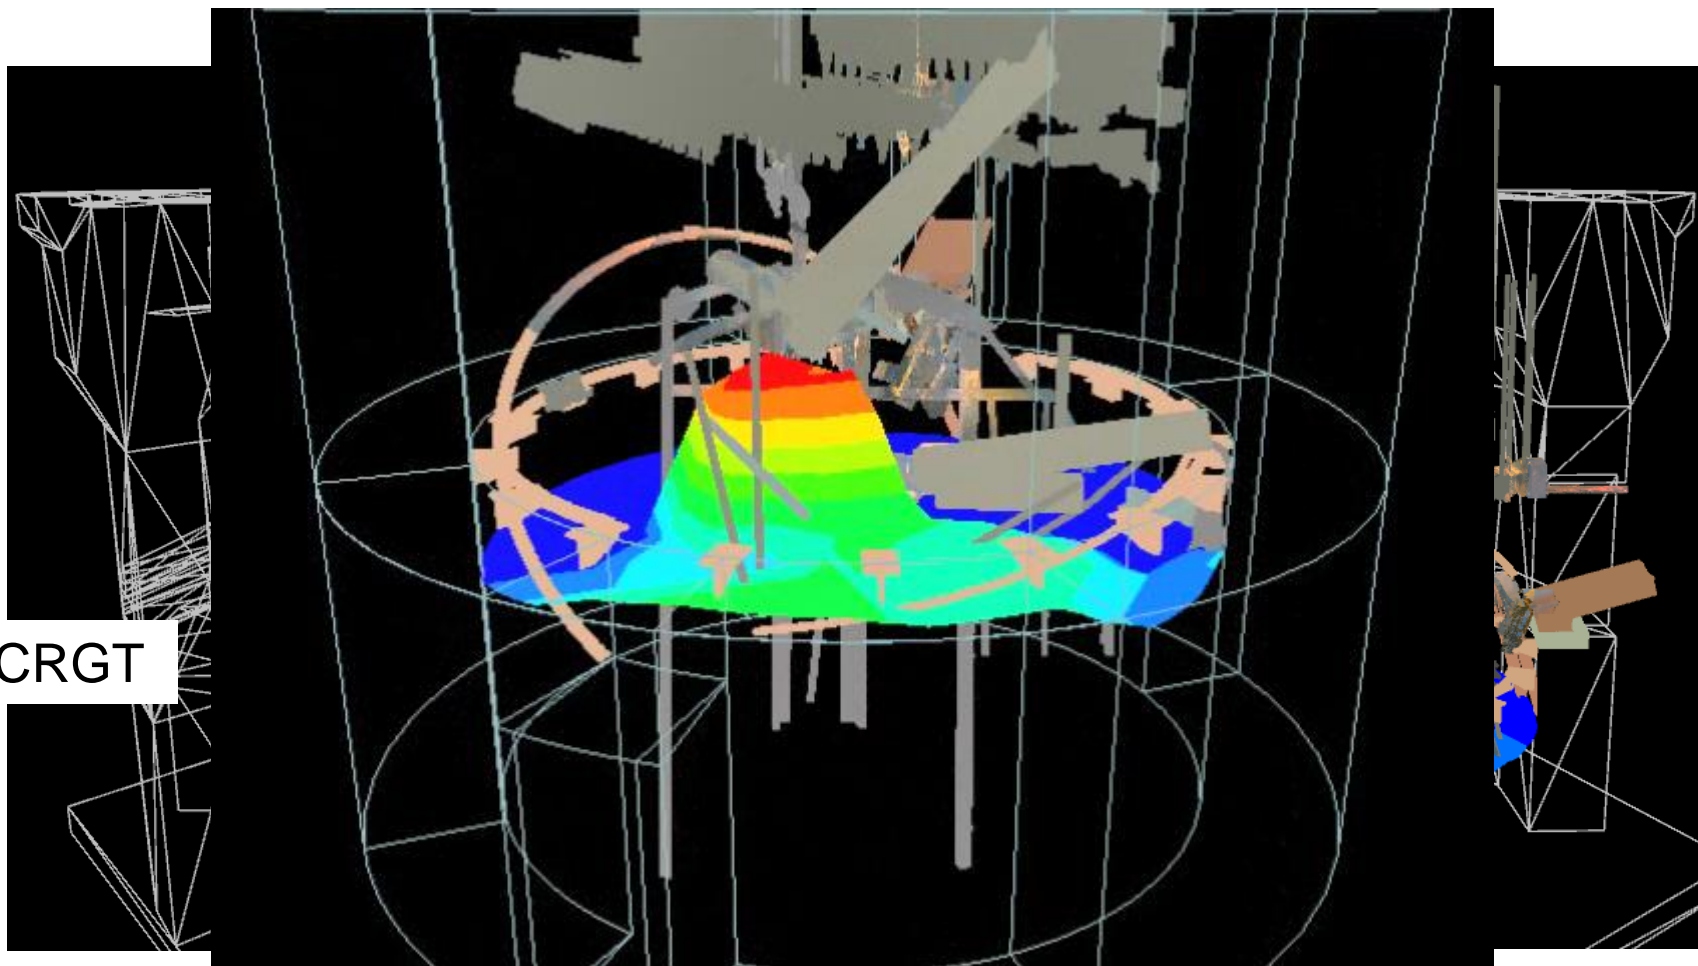
Deposits at the bottom of the pedestal are accumulated higher towards the center.
