# **Challenges Encountered at TMI 2 Defueling - Possibly applicable to 1F as Lessons learned**

GR Skillman

TMI 2 Defueling Manager 1985-1986

Presented to NDF's 7<sup>th</sup> International Forum on the  
Decommissioning of the Fukushima Daiichi Nuclear  
Power Station

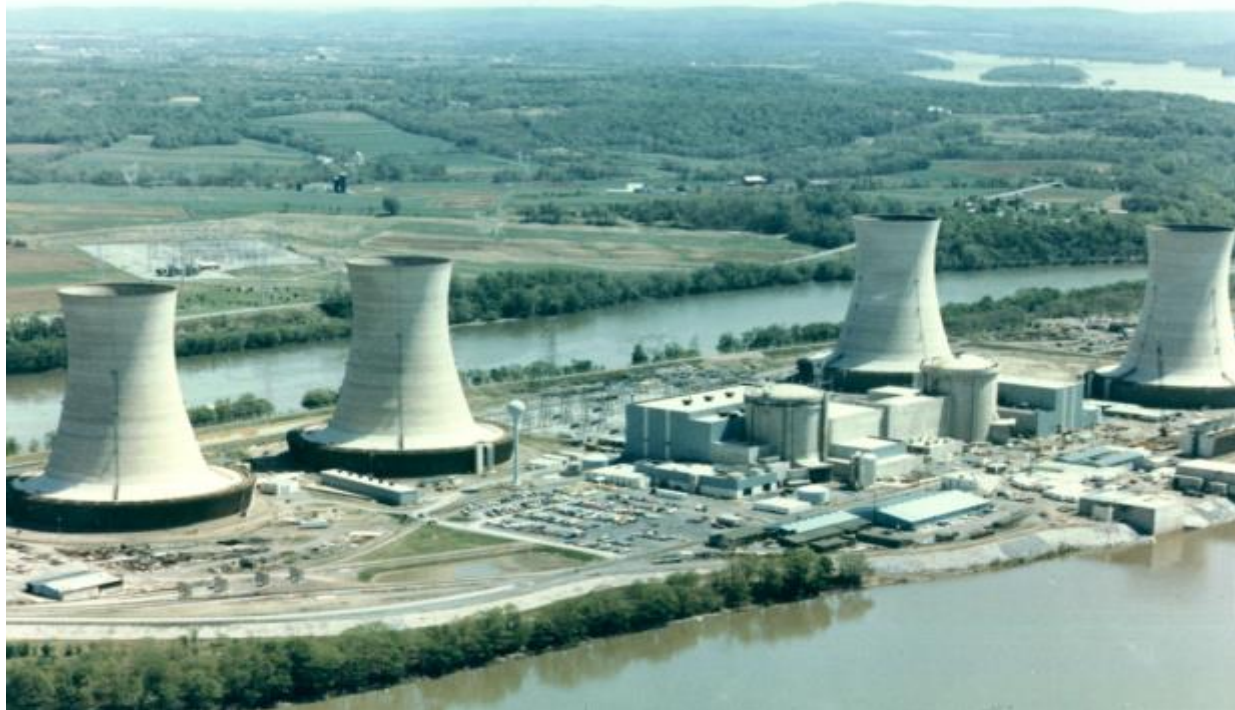
# Three Mile Island Nuclear Plant

Three Mile Island is in the middle of the Susquehanna River, Aerial View (from Northwest to Southeast)

TMI-1 – B&W NSSS - 2568 MWt – Commercial 1975

TMI-2 – B&W NSSS - 2772 MWt – Commercial 1979

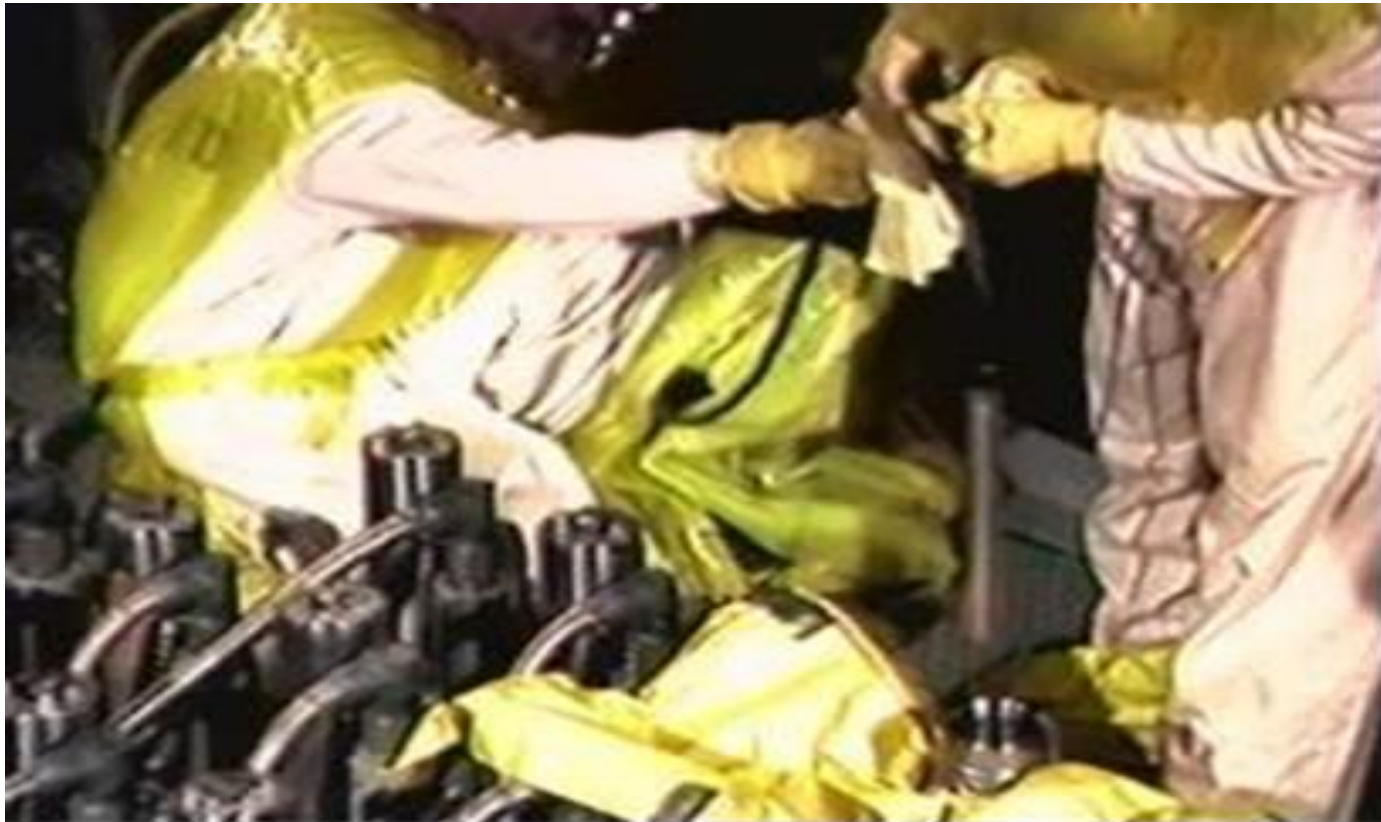
# Quick Look Team - Inserting Quick Look Camera into CRDM Opening July 21, 1982

Quick Look on 7-21-1982

Fuel Pins, Spacer Grid, Fuel Pin Upper Spring

- Three and a half years after the Accident
- Team Removed CRDM Leadscrew while standing on the Vessel Head Service Platform
- Accessed core by lowering a camera and companion light assembly through Leadscrew opening H-8, dead center of the Core
- Utilized 1.5" (~38mm ) Diameter Camera
- Discovered upper 5.5 feet (~1.5 m) of core was missing

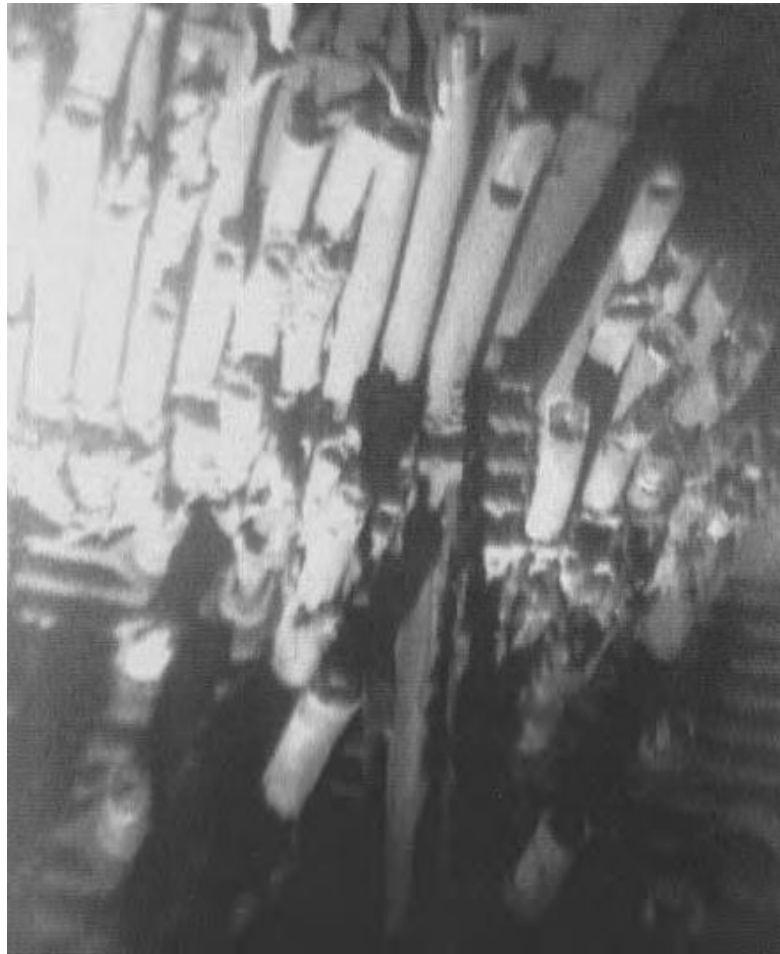
# Quick Look on 7-21-1982 Spacer Grid, Fuel Pins

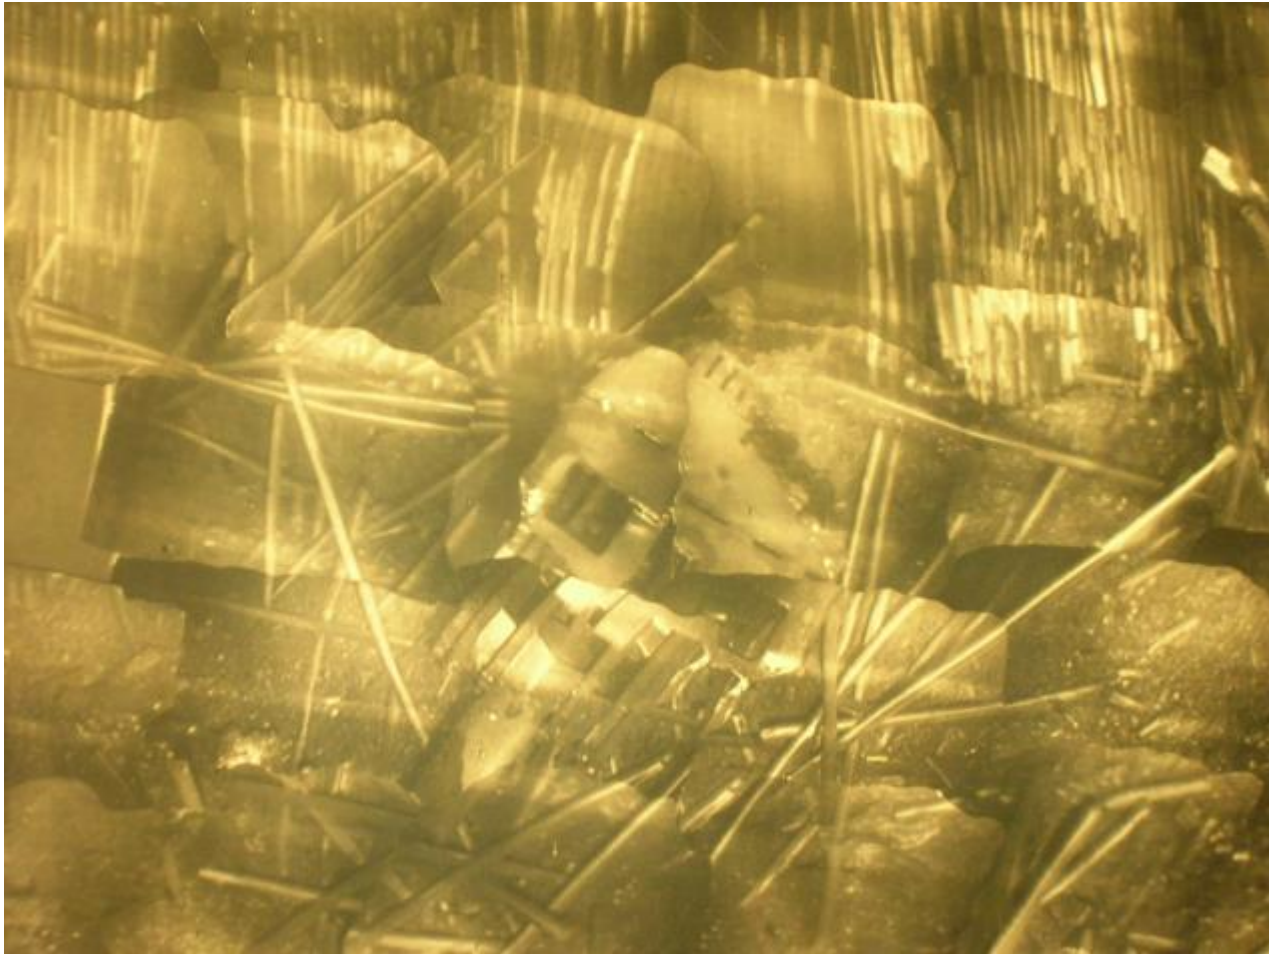
# Close-Up of core debris obtained during the 360' Panorama camera exam

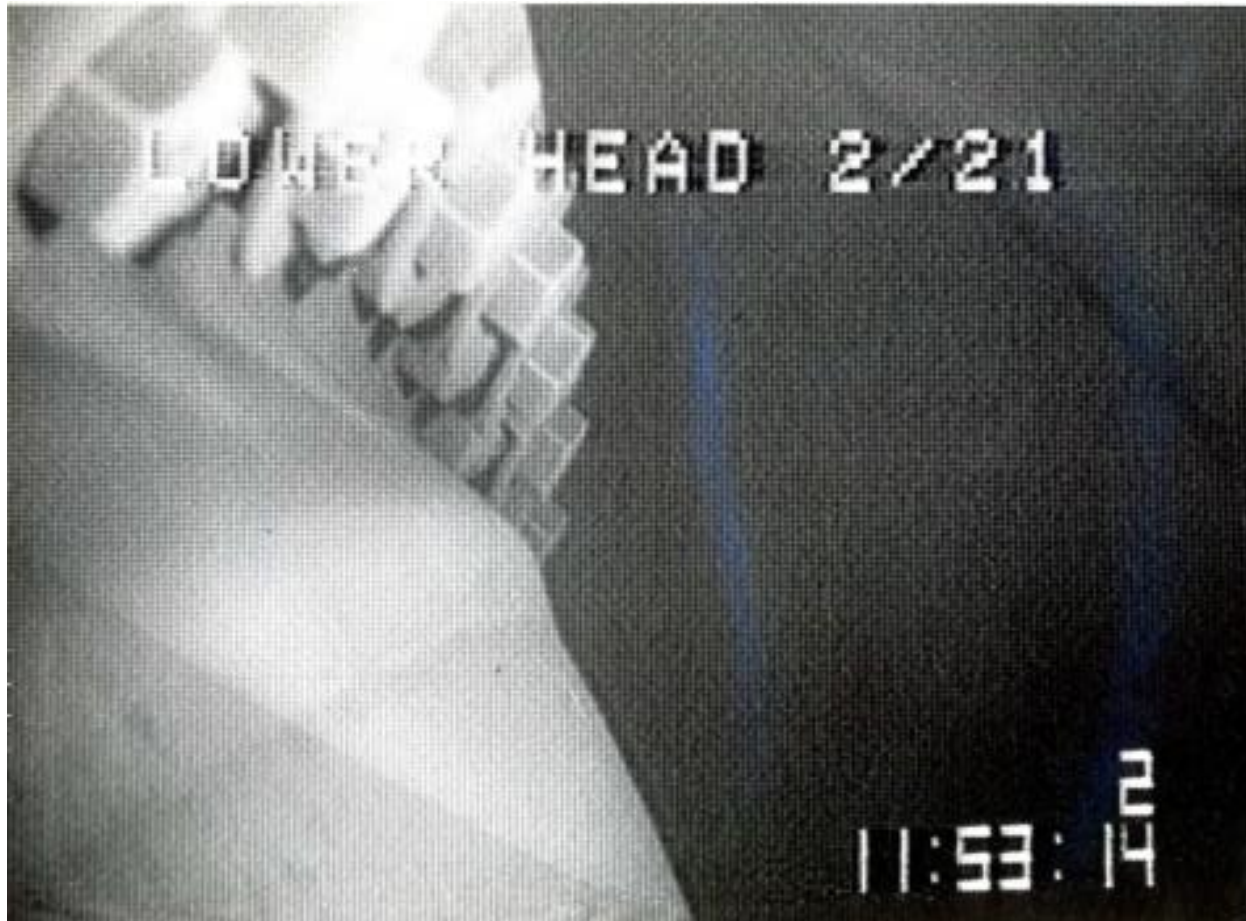
Conducted Camera Inspection of Lower Region of Reactor Vessel -  
(Image shows Bolted Connection of outer shell of CSA to Elliptical Flow  
Distributor Plate)

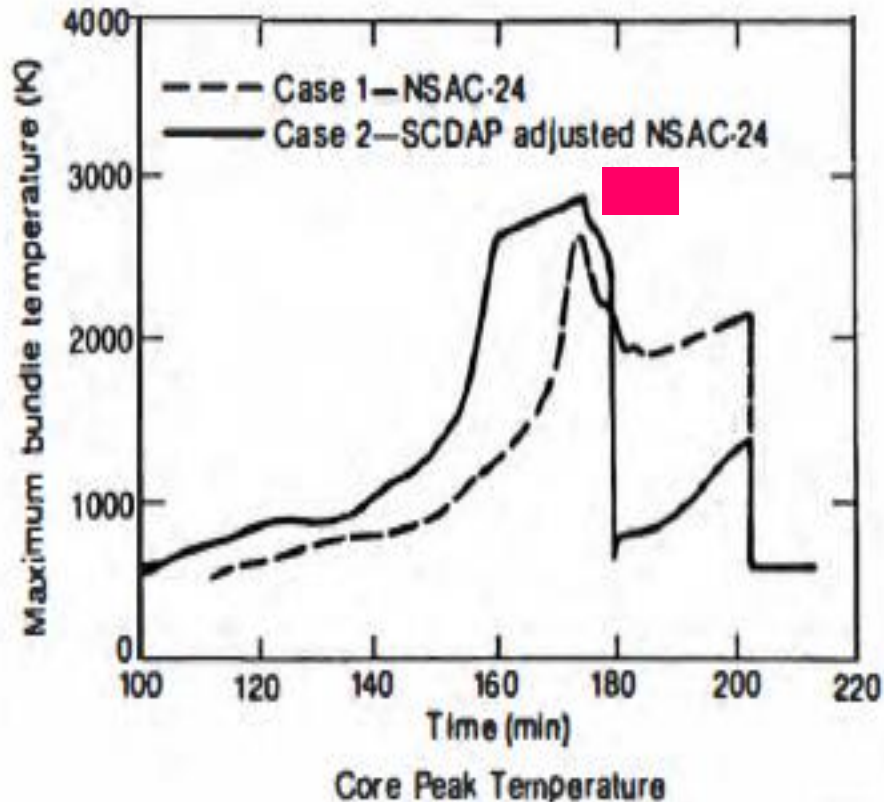
Maximum Bundle Temperature / Time Correlation  
TMI-2 ACCIDENT Evaluation PROGRAM, EG&G Idaho, February  
1986, Page 42 (2 of 2)  
See 3000'K at ~175-180 min (~0655-0700 3/28/1979)

- From an important Analyses performed by the Nuclear Safety Analyses Center - (NSAC):
  - One set of temperature measurements made between 4 and 5.5 hours into the accident indicates some temperatures in the region of 2500° F, but others were below 700° F around the outer edge of the core. (From NSAC 80-1, Technical Description, Pages 9-10)
  - All temperatures above the core center remained above 700° F (scale) limit of the recording instrumentation) for about 8 hours into the accident, and some remained above 700° F for up to 30 hours. (From NSAC 80-1, Technical Description, Pages 9-10)

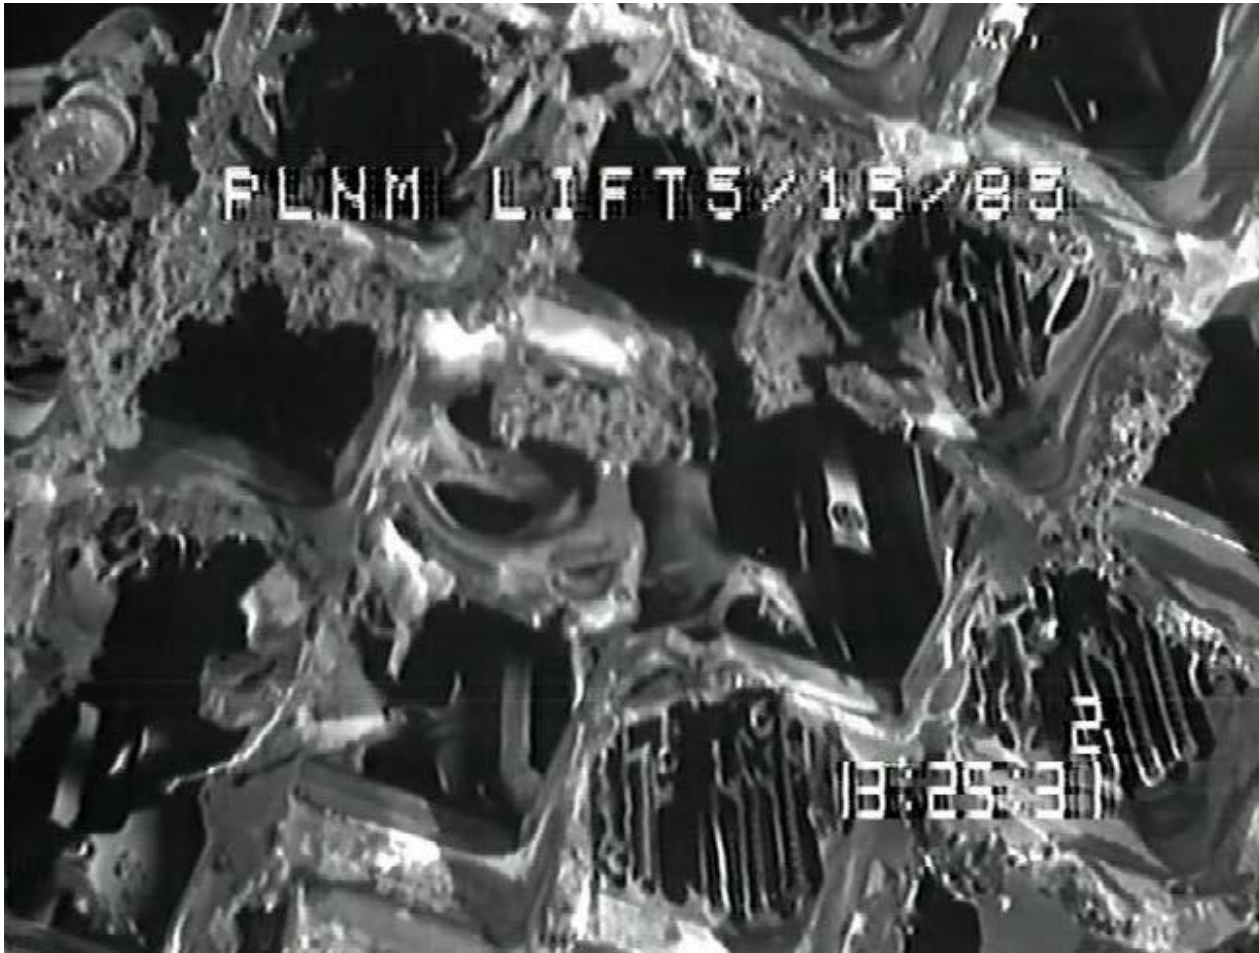
After removing the 55 ton Plenum – we observed this damage on the Upper Grid Plate

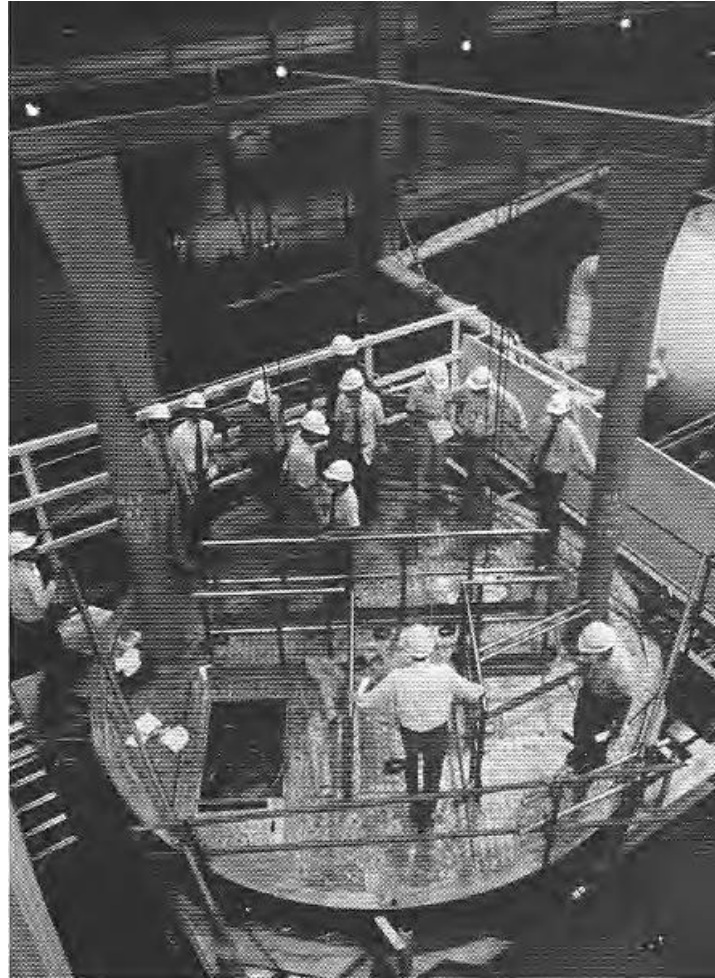
# Mock Up inside the TMI 2 Turbine Building - Identical to the Rotating Work Platform in the Reactor Building - Oversight Committee on Mock-Up

- Trained 6 qualified operators to earn Fuel Handling Senior Reactor Operator Licenses (FHSRO) from the US NRC, to enable supervising fuel removal. The FHSRO was the Supervisor for the on-duty defueling team
- Utilized original, licensed trained GPU / Met Ed Operators
- Each defueling shift was authorized to perform defueling operations independently from other organizational distractions
- Constructed and used the Mockup in the Turbine building, an exact replica of the rotating Work Platform in the Reactor Building, to train the Operators to perform defueling tasks

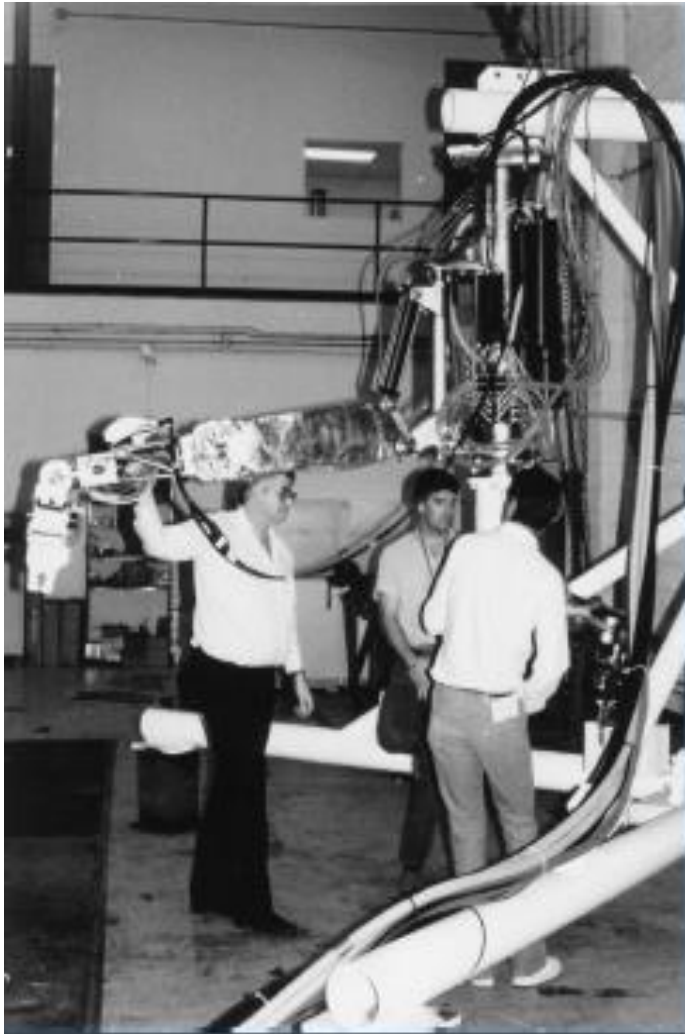
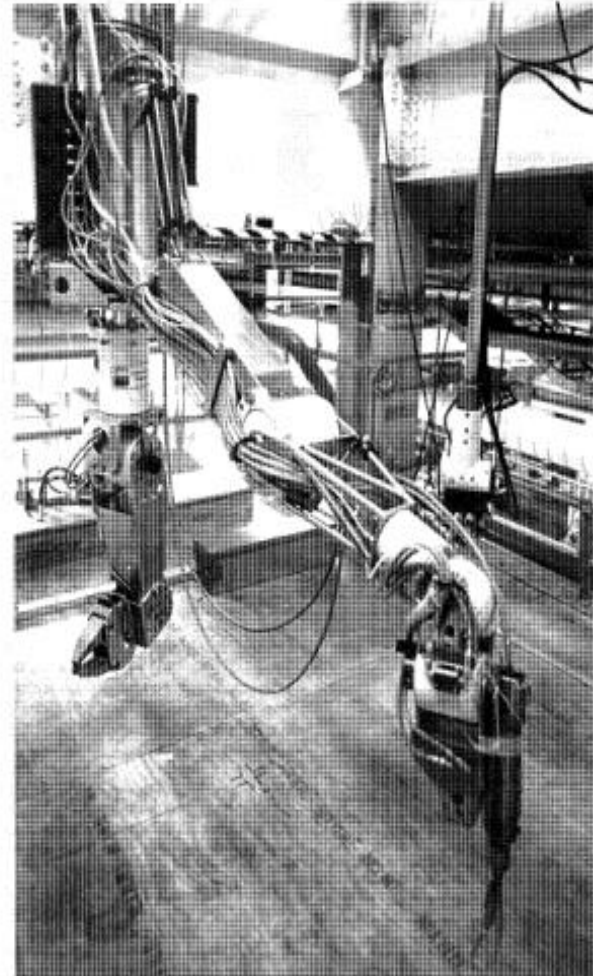
Photo 8-10, MANFRED

# Remote Defueling Concept - MANFRED – (Discarded – underwater access, maintenance, decontamination challenges)

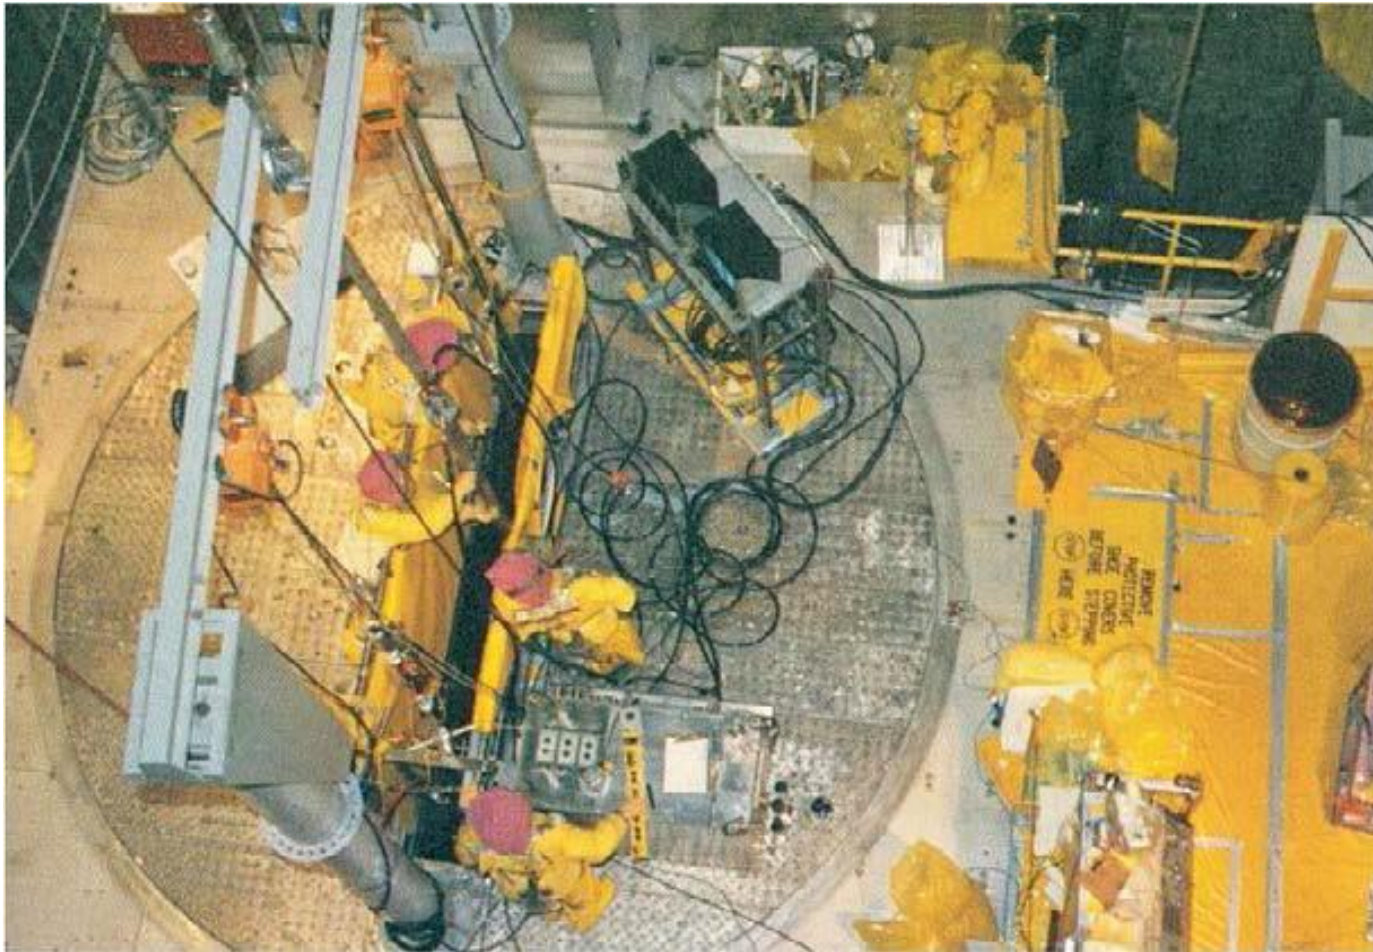
# Defueling Team working over 'open slot' in Rotating Work Platform

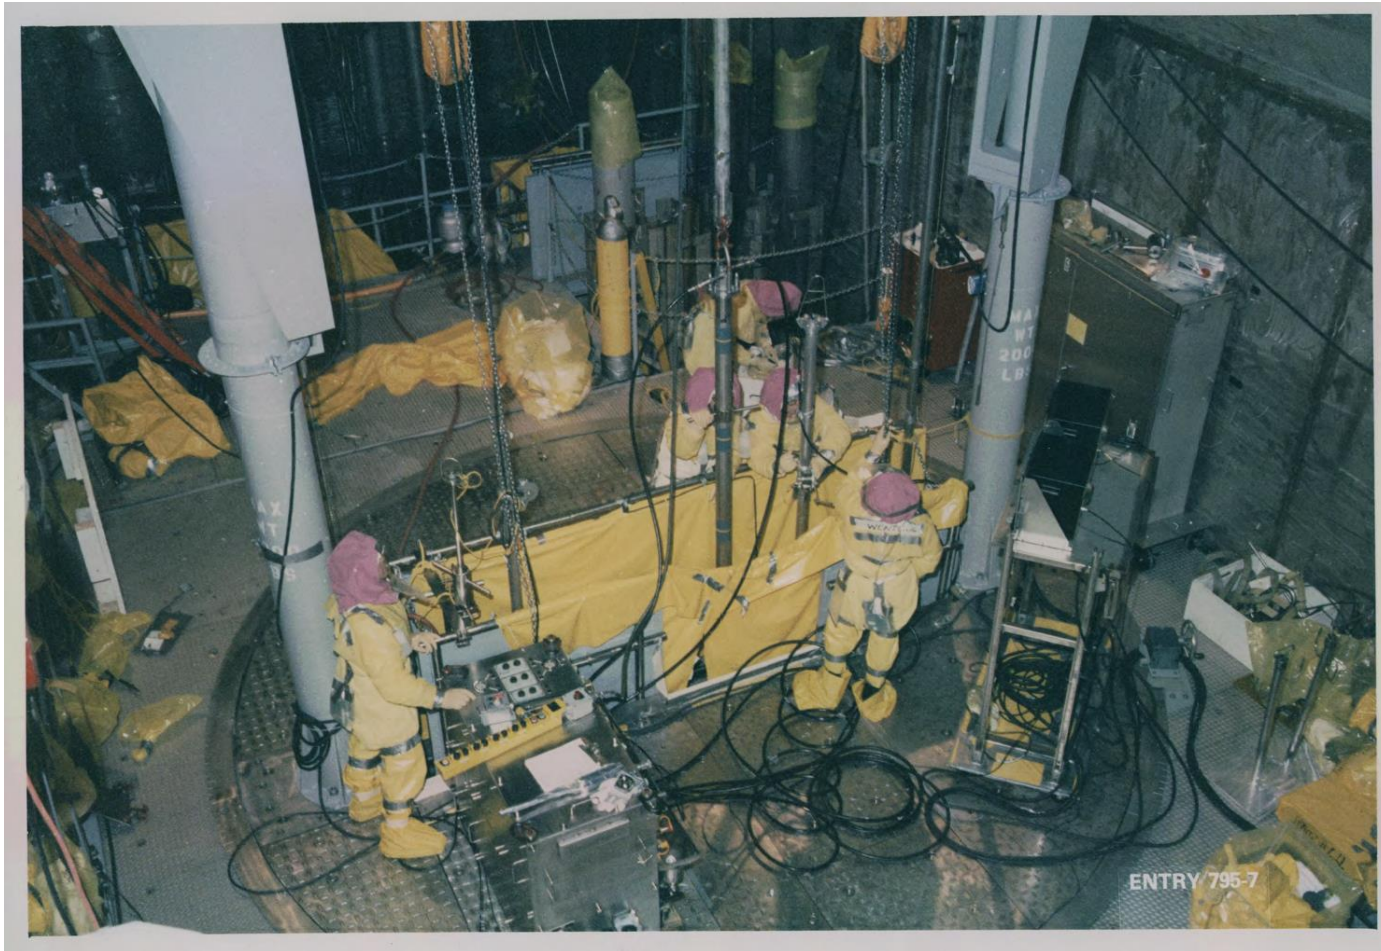
# Defueling Team on rotating Work Platform over the TMI 2 Reactor Vessel

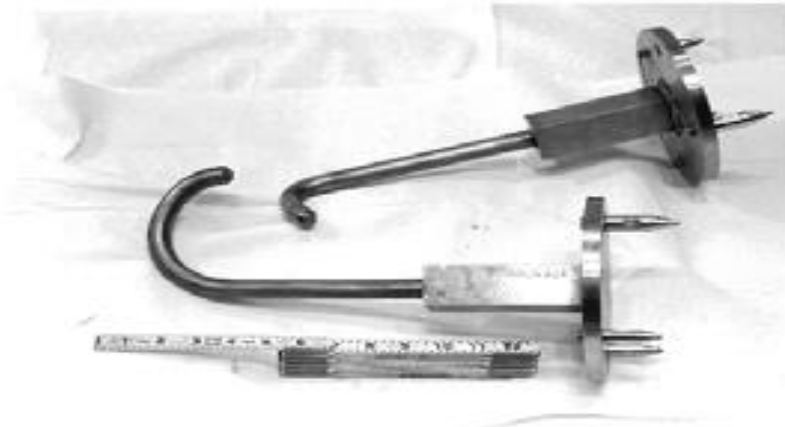
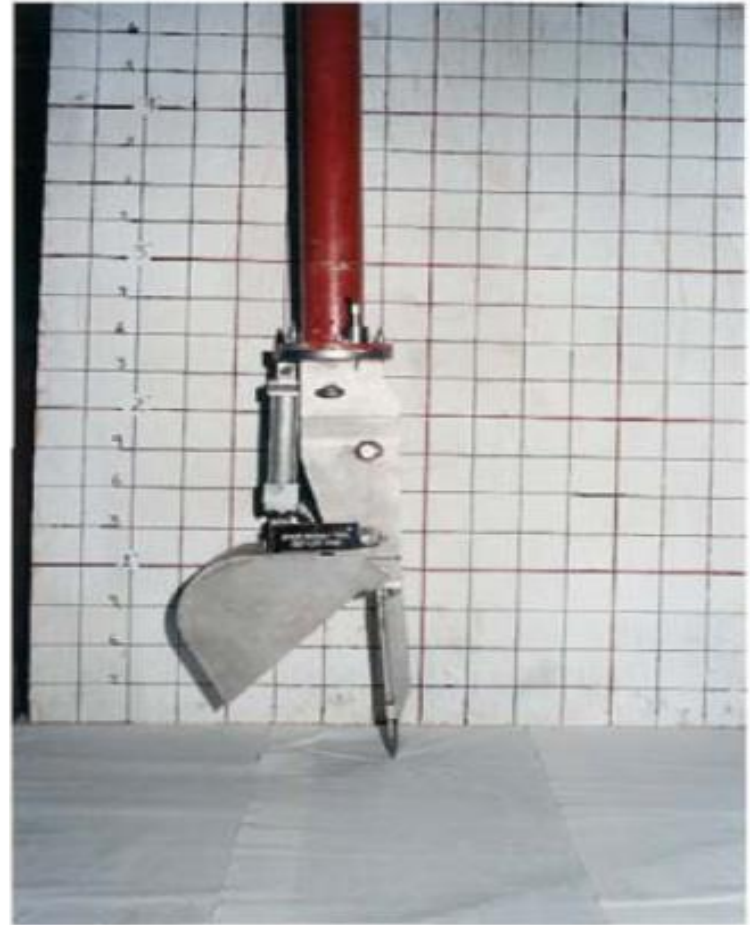
# Parting and Grab Tool, Small Clam Bucket Tool

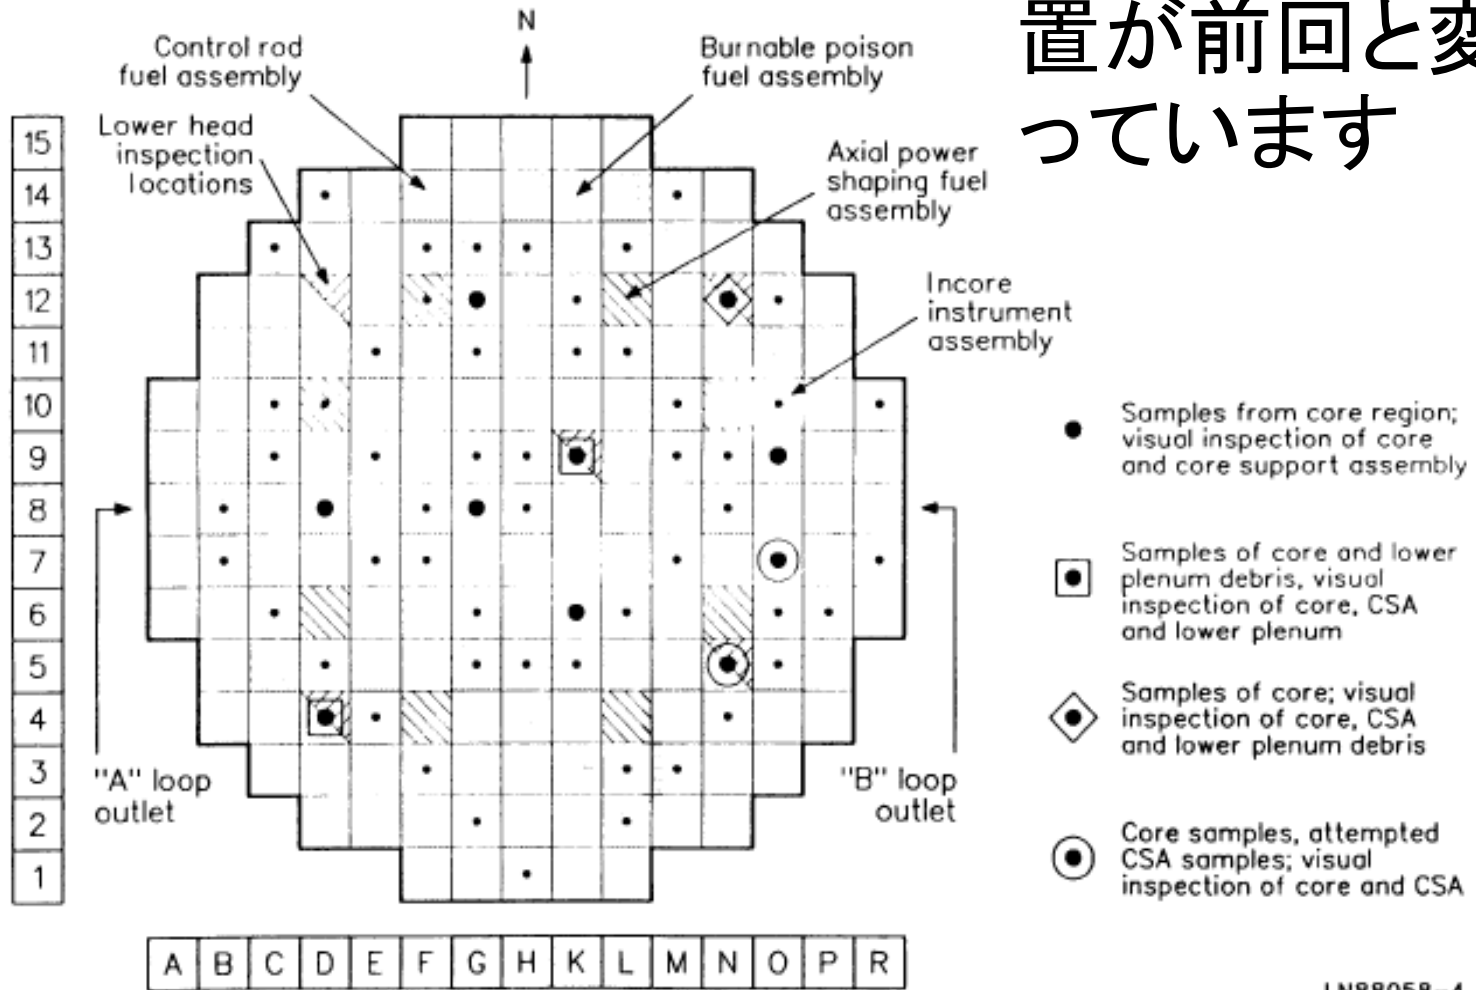
Figure 2. Core bore sampling locations.

# Core Bore Sample Locations (10)

GEND-INF-092-v1 TMI 2 Core Bore Examinations Volume 1 Page 22 (PPT)

- The Core Bore (Stratification Sampling) Program targeted 10 core locations (see Slide 61) and led to the discovery of a doughnut-like crust in the core
- The Core Bore Machine produced small debris chips (from the teeth of the cutting bit) that were removed by the Fuel Debris Vacuum System while boring was occurring. The Fuel Debris Vacuum System also removed small fuel particles. The Defueling Teams discovered that the combination of the Core Bore Machine and the Fuel Debris Vacuum System produced effective fuel removal
- The Core Bore Machine was later used as critical defueling tool making ~400 bores (“Swiss cheesing”) into the lower core. The Core Bore Machine later achieved prominence as an essential companion to the Plasma Arc Torch to access and Defuel the lower core regions

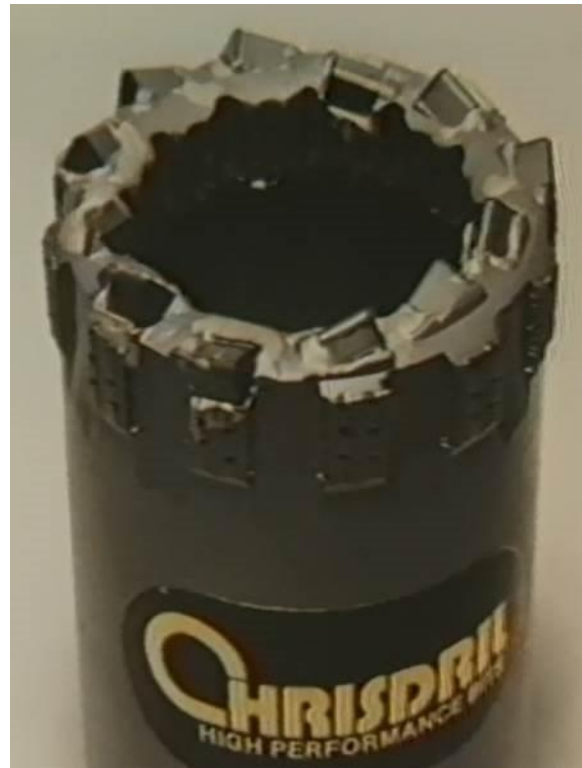
# Core Bore Drill Bit

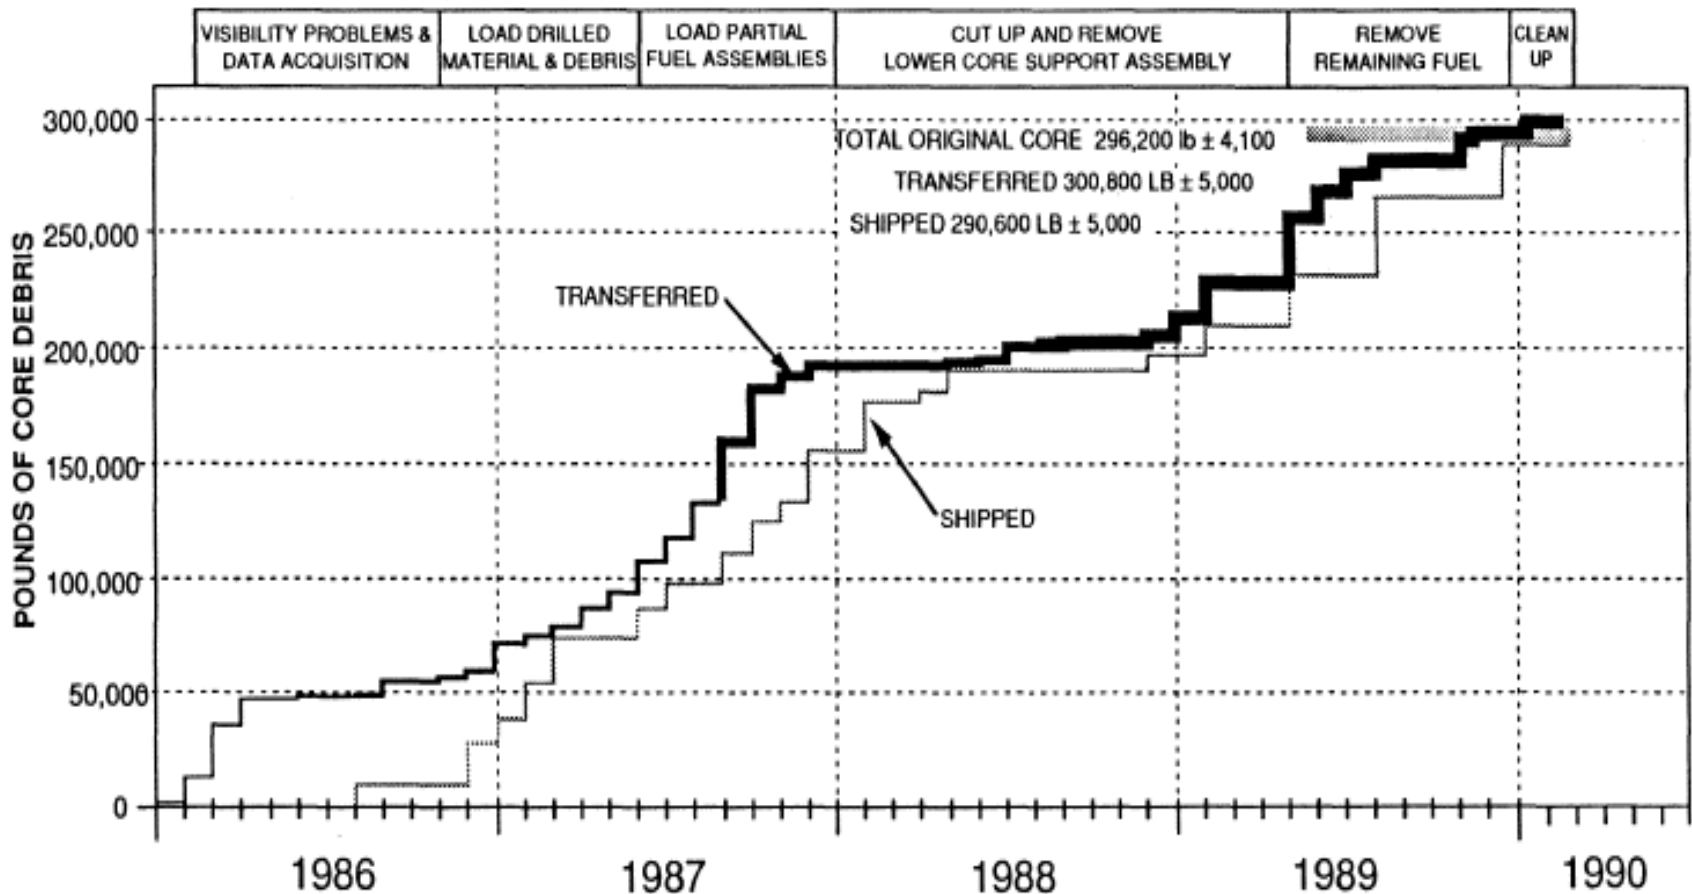
# TMI-2 Defueling Progress (Defueling Completion Report, GPU 1990)

Note: The first canisters of core debris were Transferred from the Reactor Building to Spent Fuel Pool "A" in January 1986. These canisters were subsequently Shipped to the Idaho National Engineering Laboratory for analysis and storage.
