The 7th International Forum on the Decommissioning of
the Fukushima Daiichi Nuclear Power Station

IRID's R&D Results for Fukushima Daiichi Decommissioning and Future Challenges and Expectations

Toyoaki Yamauchi
**President of International Research Institute for Nuclear
Decommissioning (IRID)**

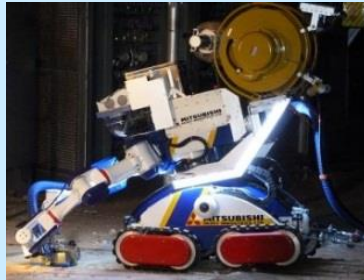
For low places (floors and lower part of walls)

Suction and blast

High pressure water injection

Dry ice blast

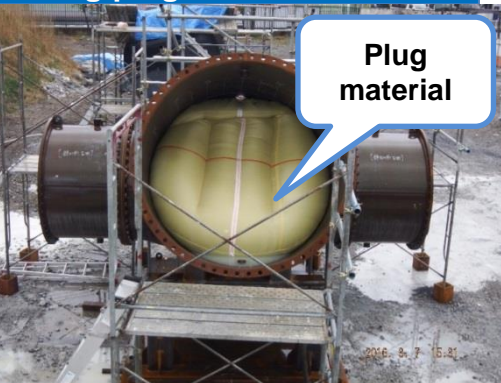
Test for stopping water leaks using plug material

Plug material

Performance of water stops using a plug material was confirmed by using the 1/2 scale facility (outdoor test).

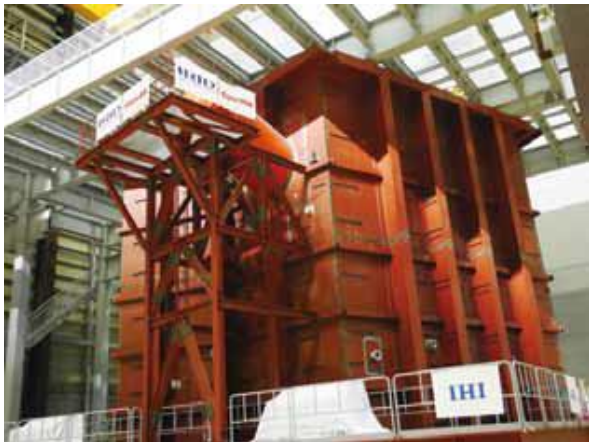
Mock-up facility

- This test aims to create a procedure manual considering an actual work and **evaluate the onsite applicability** by using a full-scale mock-up facility.

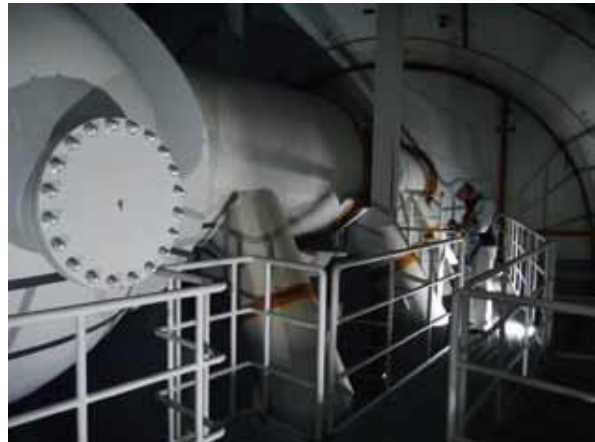
Inside of the mock-up facility (S/C interior)

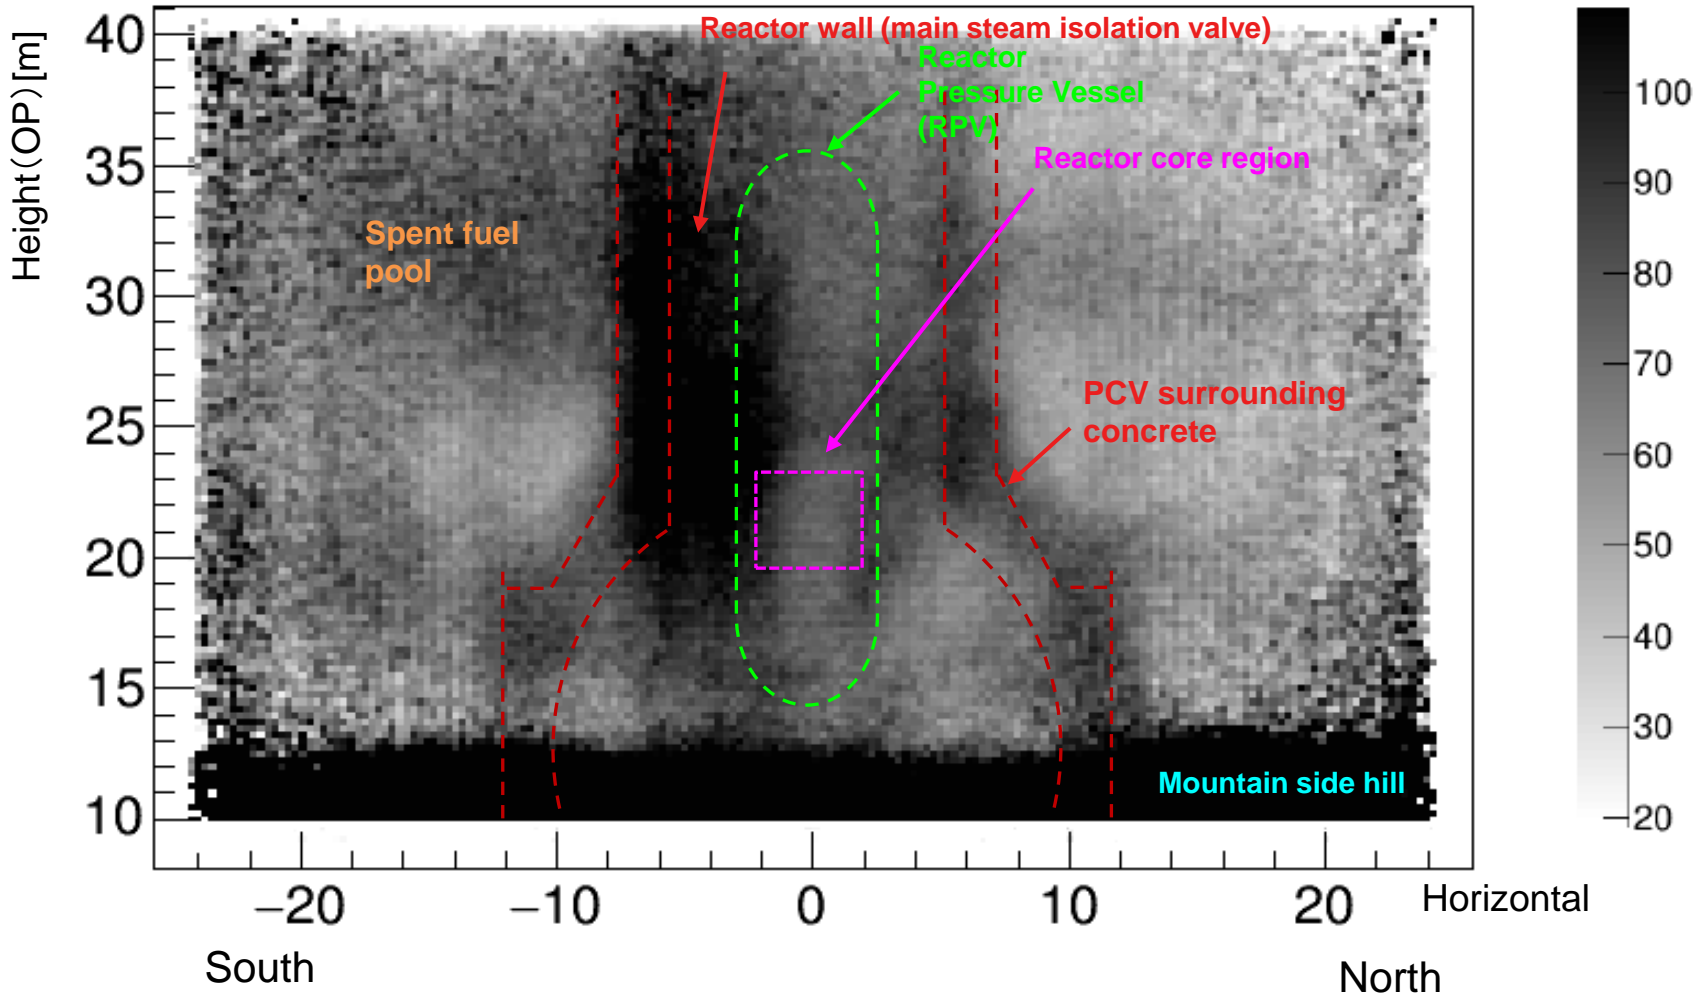
Measurement results of the muon transmission method (2014 - 2017)

No high-density substances were confirmed in the core region of the Fukushima Daiichi Units 1-3.

Measurement image of inside the unit 3

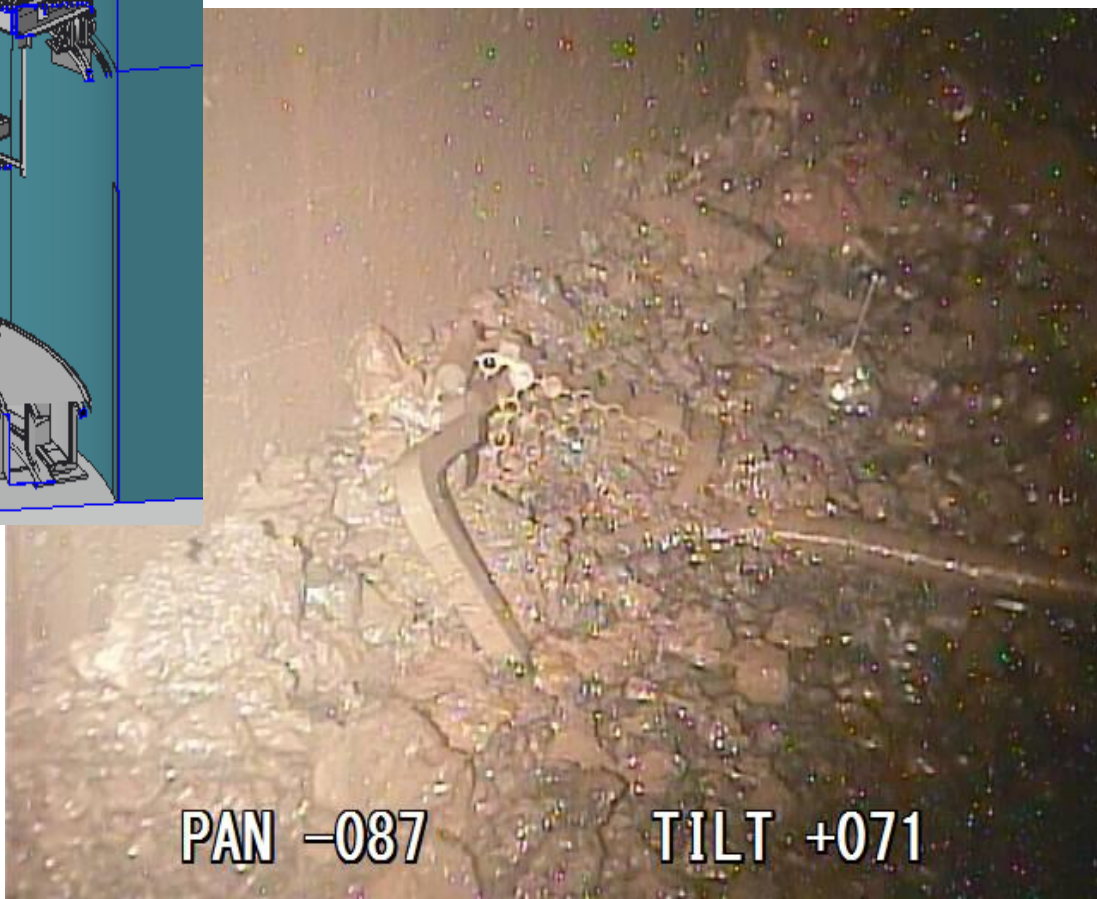
Photographing
place

The Unit 2 PCV bottom
(An overhead view)

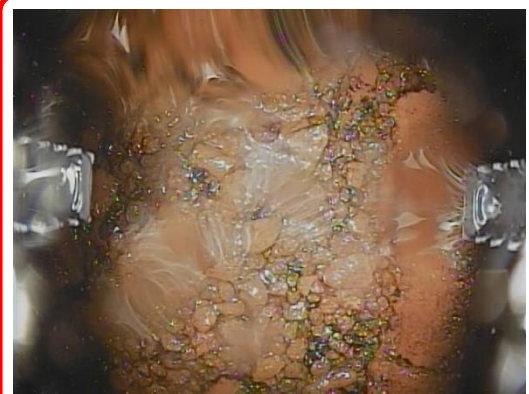
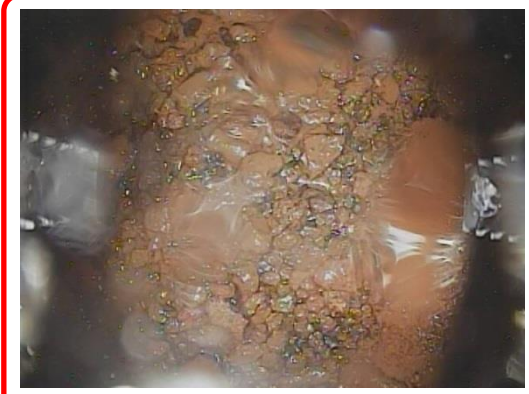
Before touching deposits

Touching deposits

After touching deposits

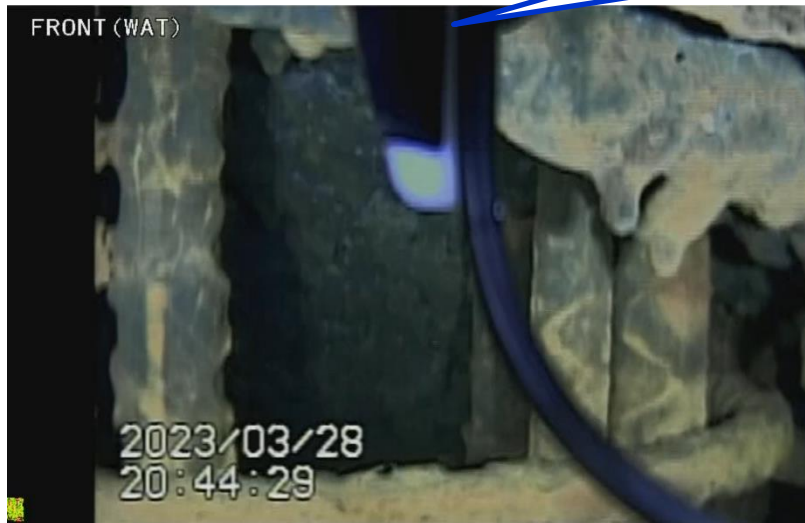
- TEPCO assumes that the lost concrete area of the pedestal inner wall (only concrete remains) is approximately 1 meter in height and 50cm in depth.
- The lost of the pedestal outer wall opening would be limited.

Photo 1: Concrete remains seen from the pedestal opening

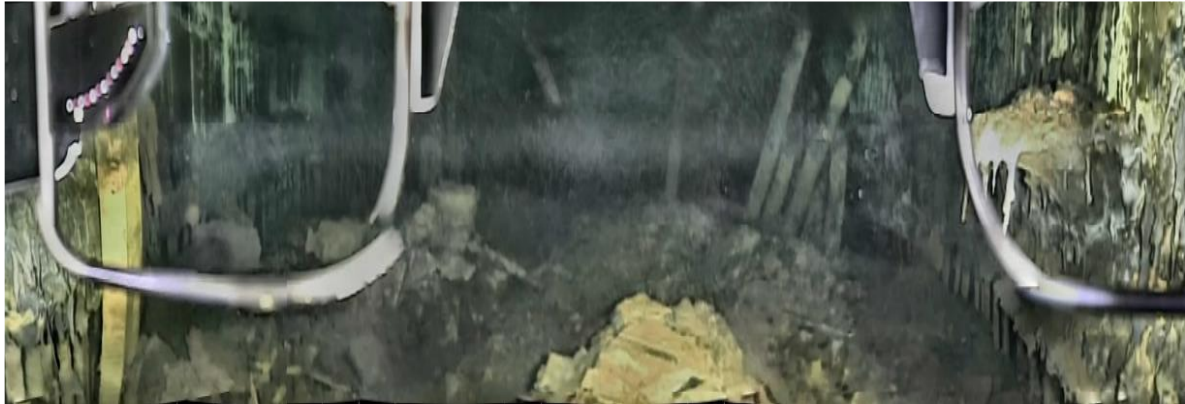
- Unit 1 has almost no fuel in the RPV, and deposits have spread outside the pedestal. The inner walls of the pedestal were also damaged.
- (The Unit 1 reactor core was damaged about eight hours after the loss of power.)

Composite image of the Unit 1 entire pedestal floor
(Reference: the TEPCO Holdings website)

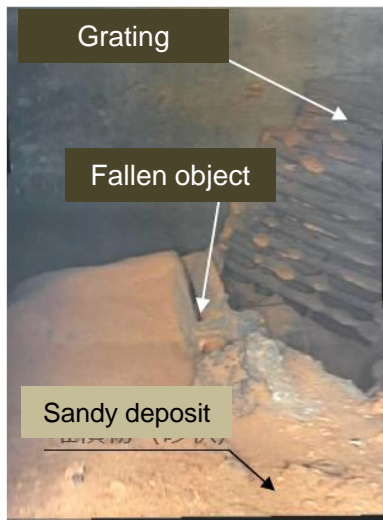
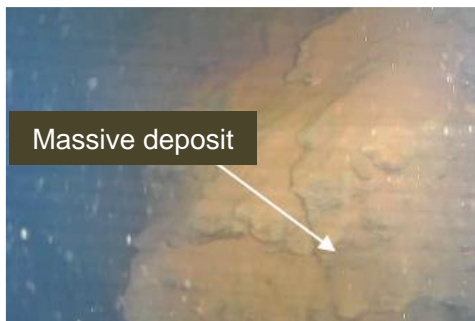
- Unit 3 has some fuel left in the RPV. There is 2-3 meters of deposits on the pedestal floor.
(The Unit 3 reactor core was damaged about one and half day after the loss of power.)

Photos taken from investigation inside the Unit 3 pedestal
