**The 7th International Forum on the Decommissioning of the Fukushima Daiichi
Nuclear Power Station @Iwaki Performing Arts Center Alios**

Historical challenges to understand the in-reactor and containment status of Units 1 to 3

August 28, 2023

TEPCO

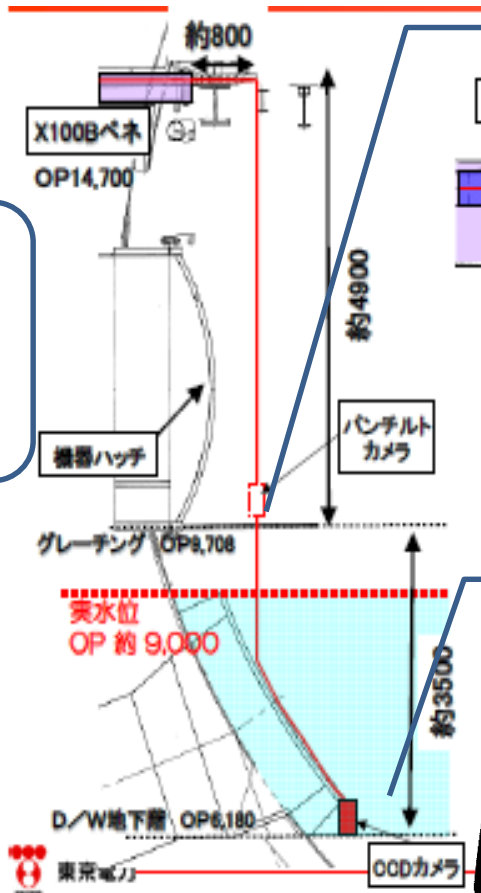
This bolt must have fixed a lead plate inside the X100 penetration hole. But, I cannot see a lead plate!

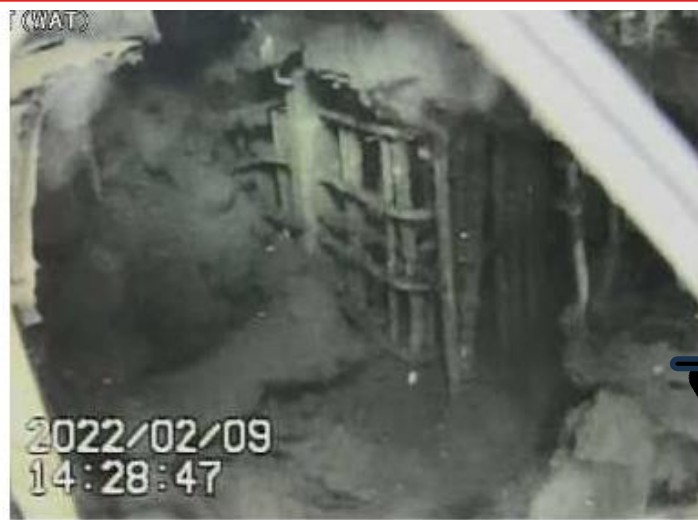
A. Near the pedestal opening

The MCCI knowledge obtained through the past experiments suggested if melted fuel drops to the concrete, it eats away the concrete vertically and then horizontally. The situation of the pedestal at Unit 1 is quite different from that!

It was confirmed that the lower part of concrete was lost and rebar were exposed at the opening of the pedestal.

This is a new piece of information for accident progression analysis and its implications for the decommissioning should be considered.

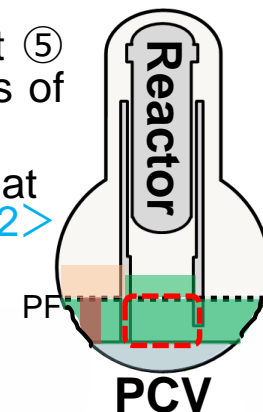
- The ROV couldn't reach points ⑧, ⑨, and ⑩. But the footage taken at point ⑤ and the one taken during its movement enabled us to ascertain the base parts of pedestal. <Photo1,2>
- The observed base parts look similar to other investigation points with concrete at the lower inner part of the pedestal partially lost and rebars exposed. <Photo1,2>

The concrete has been confirmed to be lost along all circumference inside the pedestal.

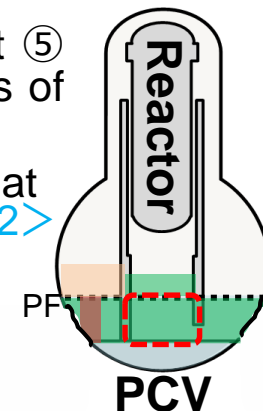
Photo 1: Point ⑧ at pedestal base

- The ROV couldn't reach points ⑧, ⑨, and ⑩. But the footage taken at point ⑤ and the one taken during its movement enabled us to ascertain the base parts of pedestal. <Photo1,2>
- The observed base parts look similar to other investigation points with concrete at the lower inner part of the pedestal partially lost and rebars exposed. <Photo1,2>

**Why is it that pedestal concrete has been lost around almost its entire circumference?
Why are the missing sections all approximately the same height?**

The concrete has been confirmed to be lost along all circumference inside the pedestal.

- Three steps are being taken, considering that the concrete has been lost at the lower part of the pedestal.
 1. Assessment of the effects have been conducted by evaluating the strength of the inner skirt remaining in the pedestal. The result shows, even with the Mar. 2011 class earthquake, the structure will not suffer large scale collapse.

2. Assuming that the support function of the pedestal has deteriorated, a conservative scenario has been made. The result shows 0.03~0.04mSv per incident at the site boundary, which is much lower than 5mSv per incident, the criteria for accident scenarios.

3. In case of loss of the supporting function, measures to prevent the radioactive dust from dispersing will be in place.
 - Preparation to stop injecting nitrogen in case of emergency based on the idea that the amount of nitrogen injected should be smaller than that of exhaust for ease of controlling the dust leakage.

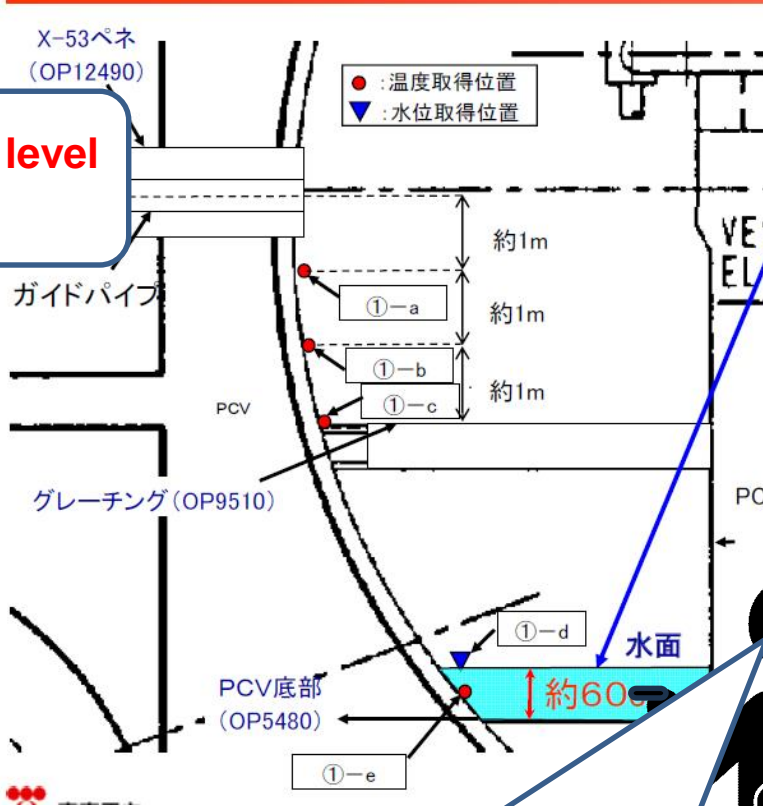
**The PCV water level is no higher than the one in the venting piping that leads to suppression chamber.
Does that mean water leakage from venting piping or suppression chamber?**

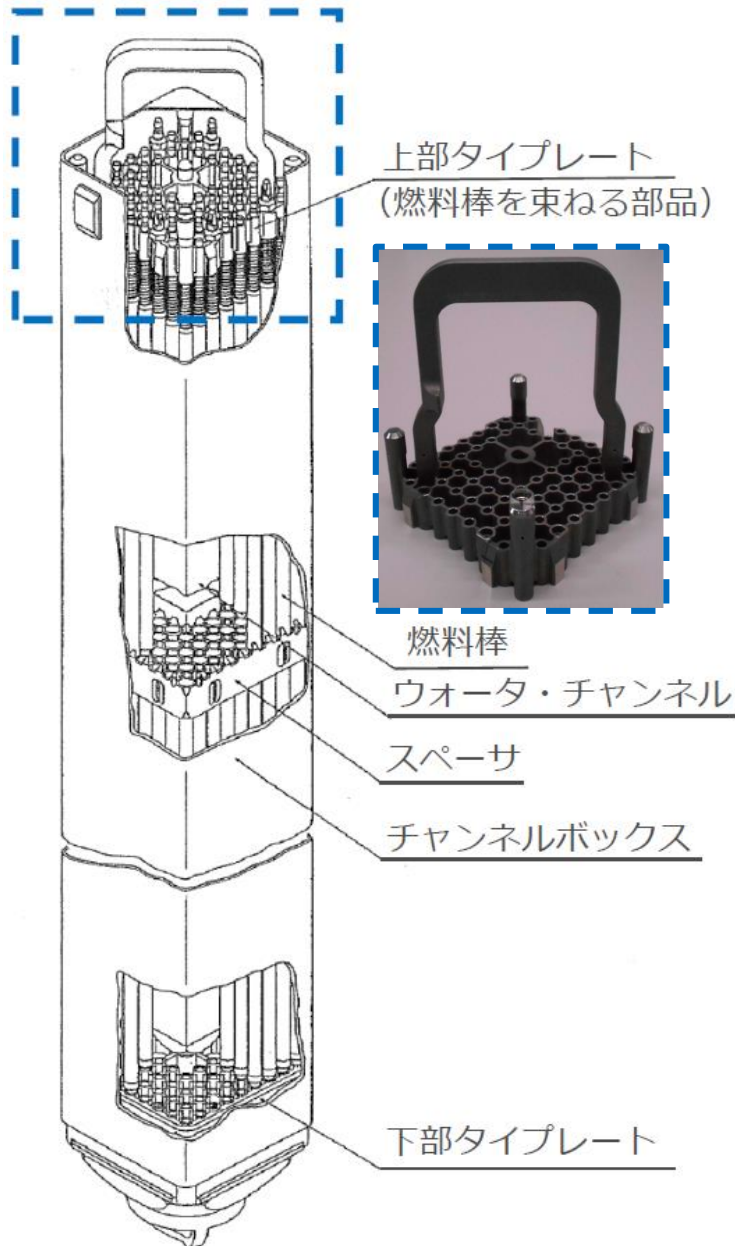
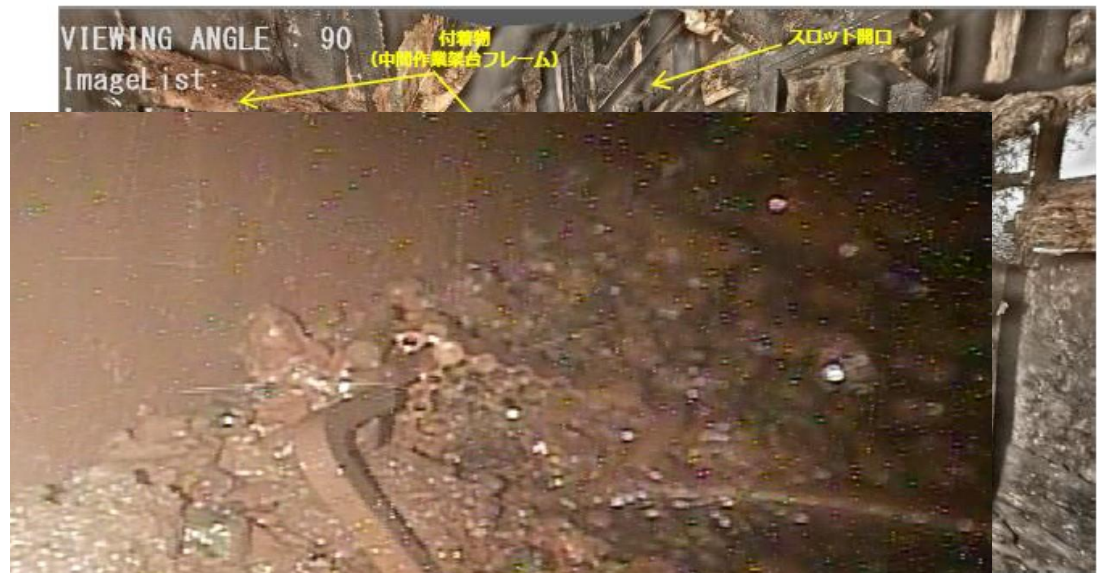
Pebble-like deposits spread all over the floor inside the pedestal. Moreover, there are a couple of places where deposits are accumulated higher than others

Do the higher places correspond to the locations where fuel debris dropped from above? If that's the case, the RPV is likely to have a couple of holes! The fact that a handle was found which used to be a part of the fuel assembly indicates that the scale of hole is no smaller than.....,

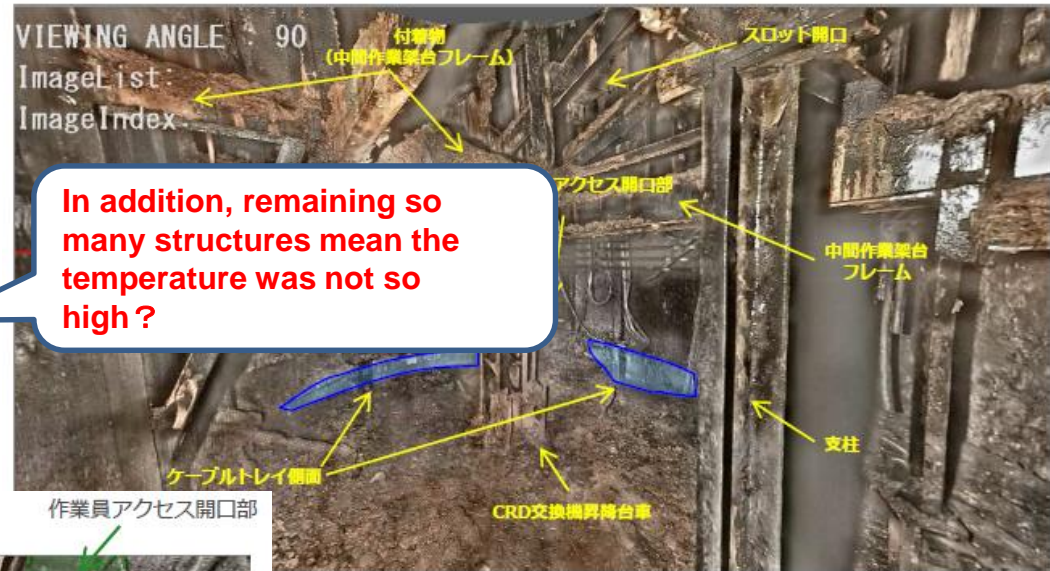
In addition, remaining so many structures mean the temperature was not so high?

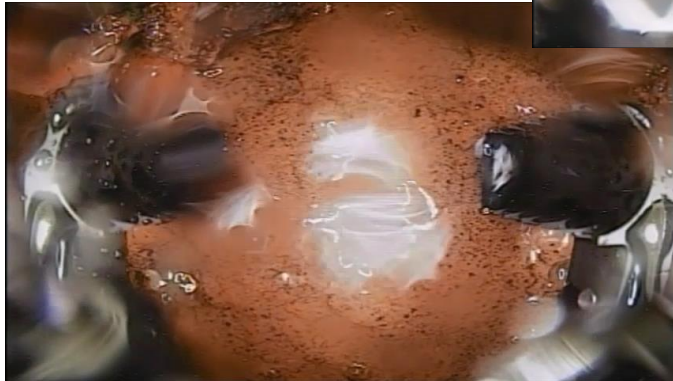
But, rock-like deposits can't be moved.

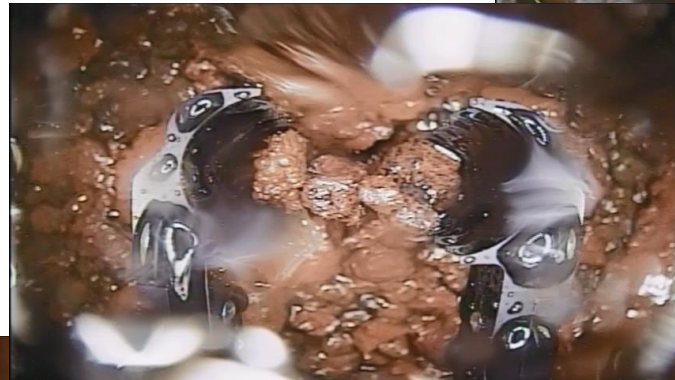
You can pick up pebble-like or plate-like ones. Those should be retrieved as well!

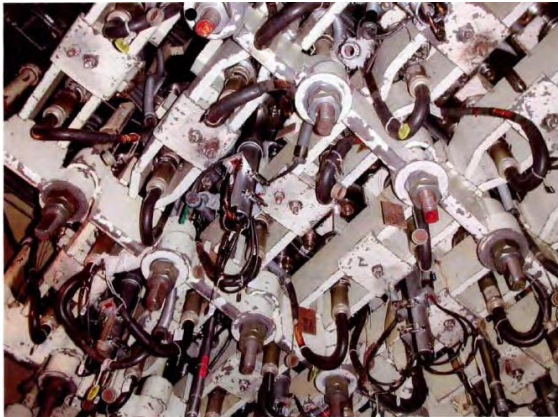
An investigation inside the pedestal at Unit 3 PCV using an underwater ROV in 2017 (1)

CRD housings are exposed with CRD housing support lost

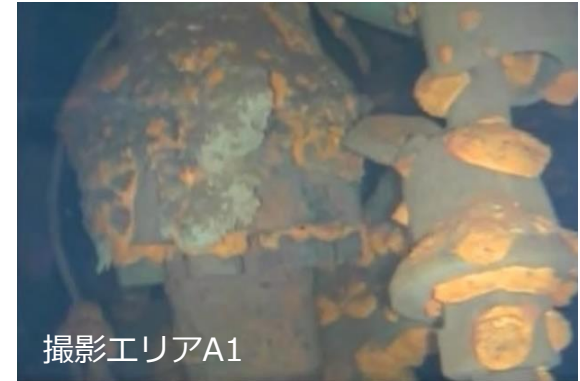
撮影エリアA1

Wavering water surface indicates water coming down from the reactor

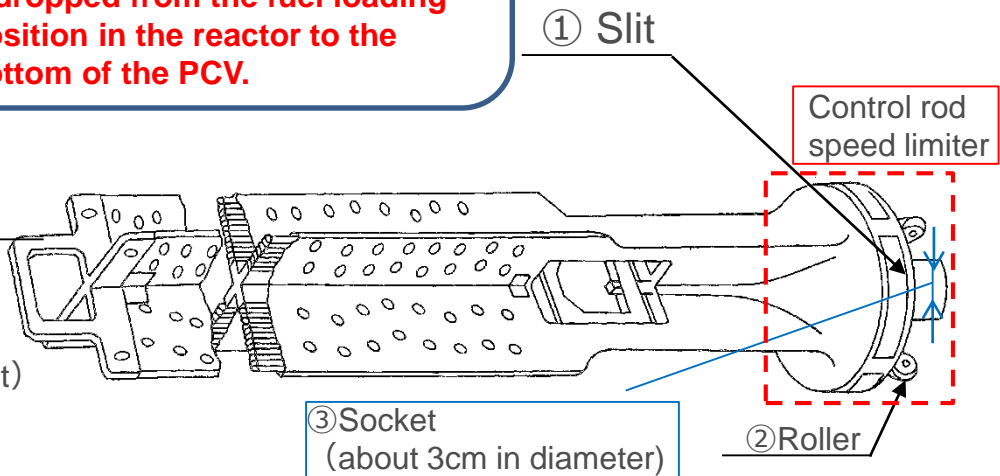
② Roller
③ Cylinder-like structure (Presumed socket)
